## Chapter 4. The Enemy Below

#### 4.1. The Desagüe del Jaroso.

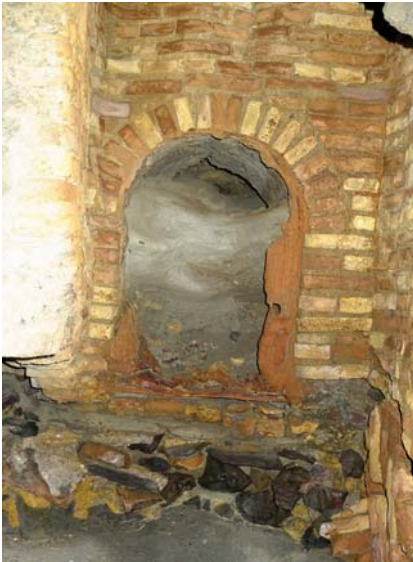
*Left, water was probably pumped out through the lower aperture into the tunnel under the present course of the Jaroso rambla.*

*Right, the higher aperture may have been for ventilation.*

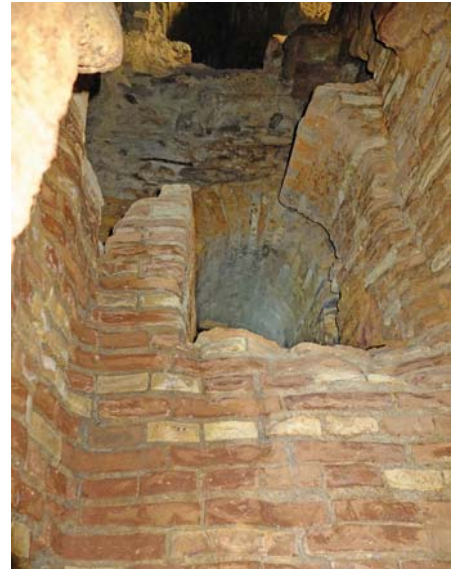
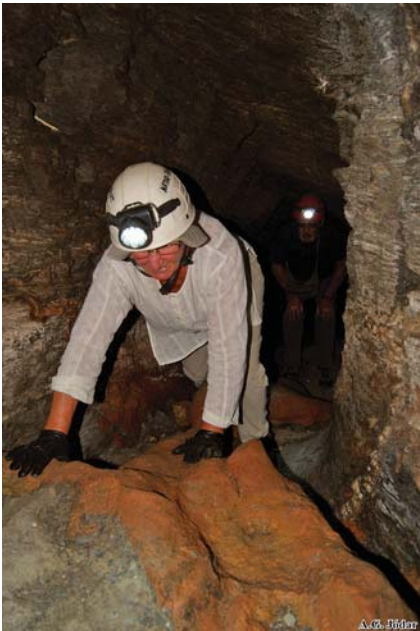
*Left, the encrustations formed by the salts and minerals in the water can clearly be seen on the tunnel floor*

*Right, the tunnel leading to the desagüe is a classic coffin adit.*

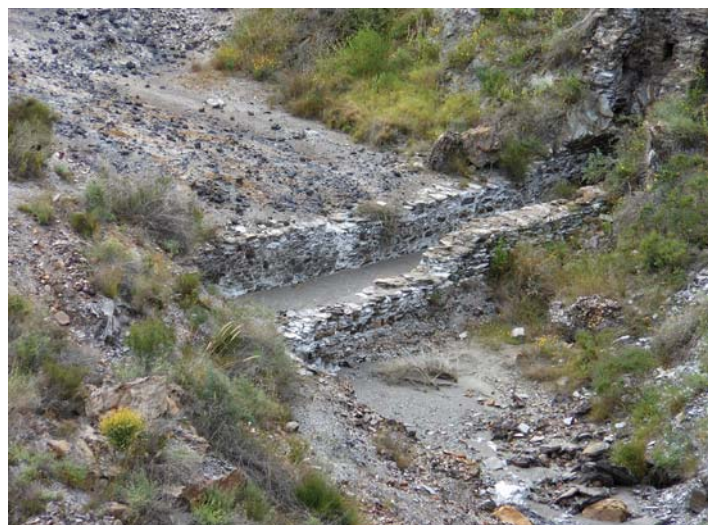
*The entrance to the combined rain and pumped water tunnel is on the right.*

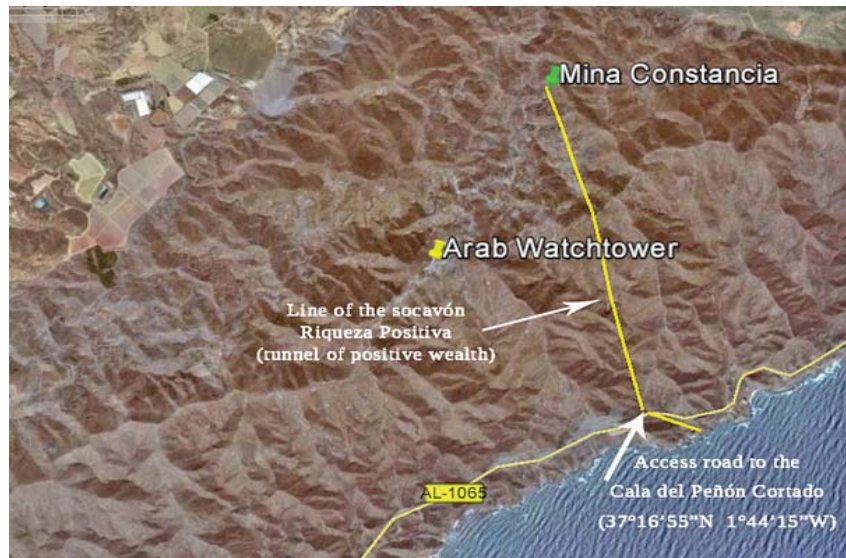
*The line of the tunnel under the Sierra.*

The socavón started 177m below Constancia and passed through the old workings in adjacent mines, going under San Cayetano to the seaward side of the Sierra. This 2 metre high and 2.5 metre wide tunnel maintains a gradient of 1 in 1000, its outfall is 2 metres above sea level in the Cala del Peñón Cortado. The water flowed through wooden trunking set in the floor. There are several lumbrera or ventilation shafts along its length, the first situated just a few metres from the exit.

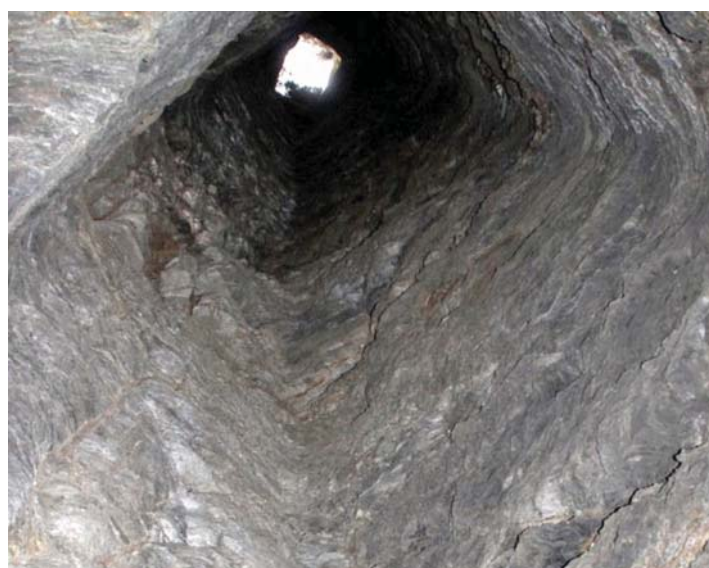
*Looking up through the first lumbrera.*

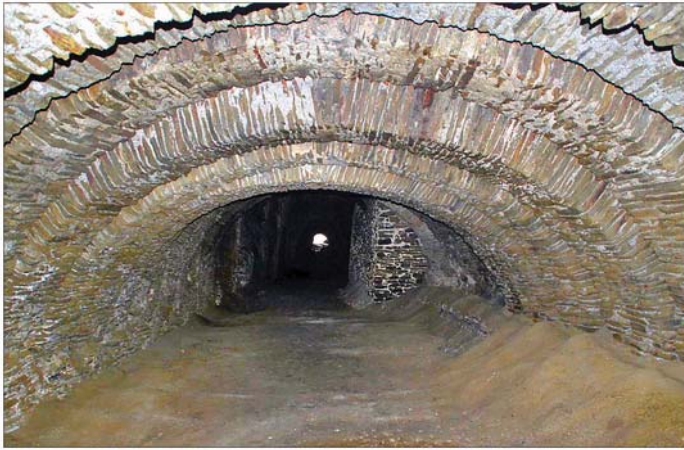
*The interior of the tunnel looking towards the exit. Mtblog.*

On the coast side is it reinforced by brick arches. The bricks were made in the specially constructed, nearby, brick oven. It was hoped to use the gallery as a corridor for moving minerals from adjacent mines to the coast, but economic difficulties and changes of ownership meant that this never happened. It is possible to walk for quite a way into the tunnel before it is blocked by a fall.

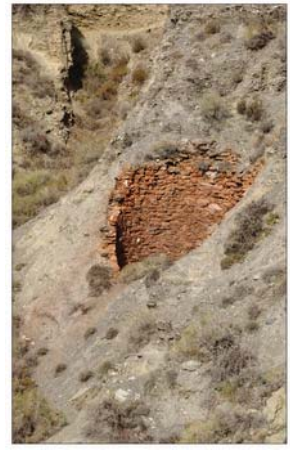
*The brick kiln.*

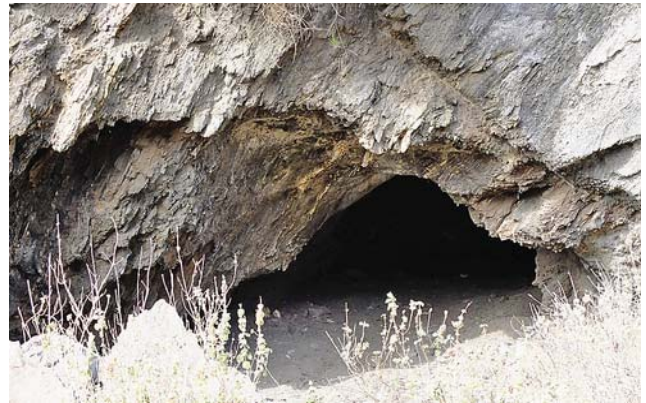
*Entrance to the tunnel from the beach.*

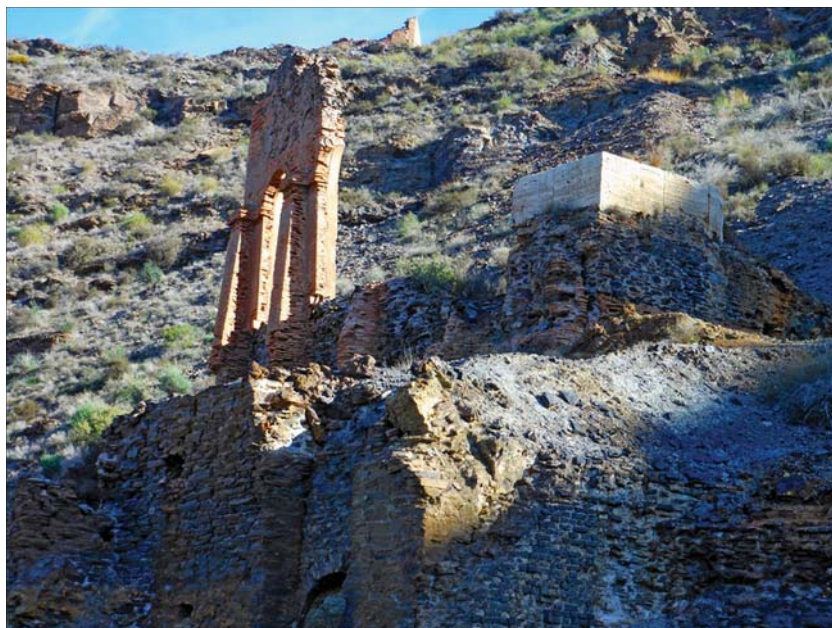
*All that remains of the Desagüe del Jaroso today.*

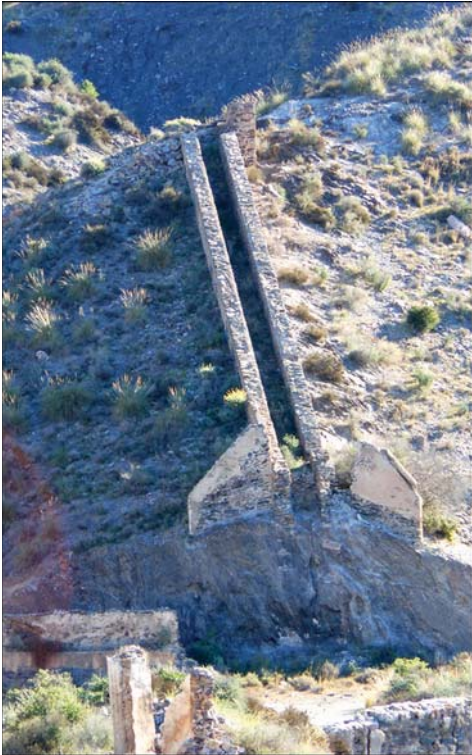
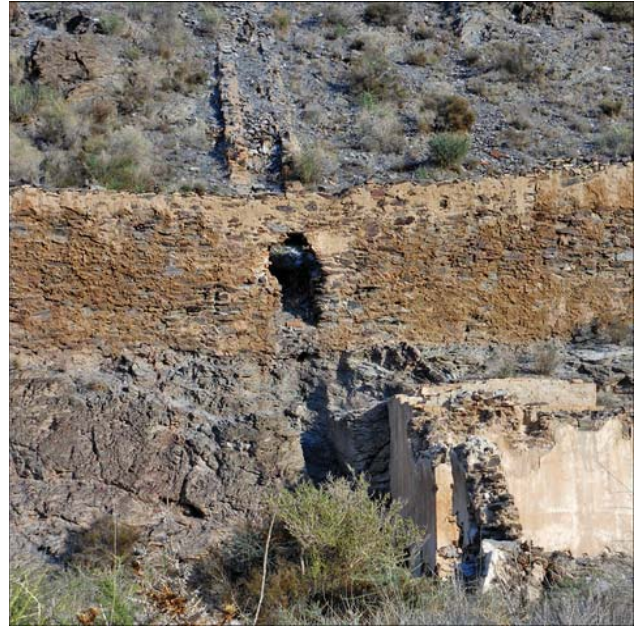
*Left, the condensation channel from the boilers and, right, the ventilation channel running up towards Isabelita.*

An interesting feature of both desagües is the sloping condensation channels from the boilers. The Jaroso one is stepped, while that of San Juan is straight. Both had a chimney at the top and, presumably, the San Juan one had a covering. Sloping condensation tunnels from boilers are a feature in the Sierra and I suspect there was a water recuperation element to them. There is a second, sloping channel, leading up towards the mine Isabelita. This one, however, was to increase the updraught from the ventilation shaft in the area by the curtain wall.

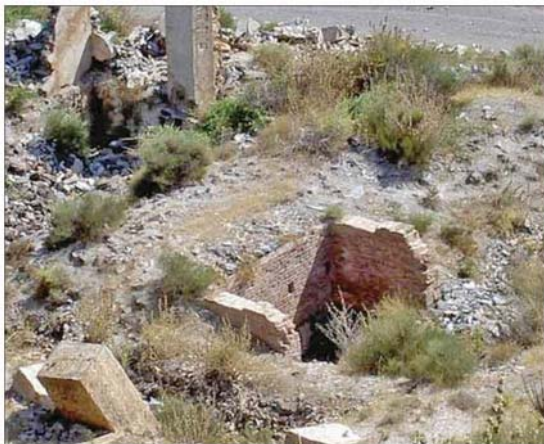
*The San Juan shaft and the remains of the engine room*

The San Juan shaft, part of the Crescencia concession was extended to a depth of 220 metres and widened to 3.30 metres by 2.10 metres. It was twinned with the ventilation shaft sunk over by the curtain wall.

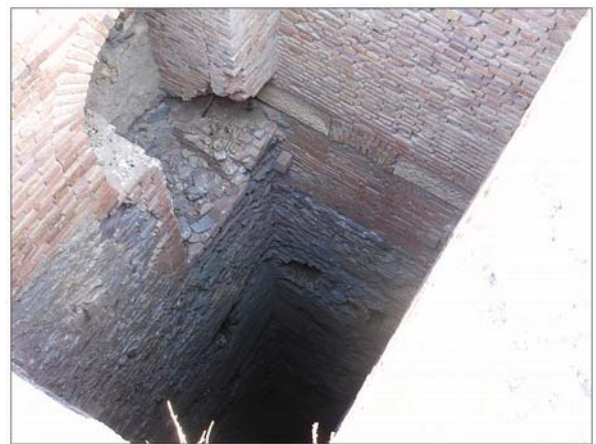
*The water at the bottom is 35° C. and is red.*

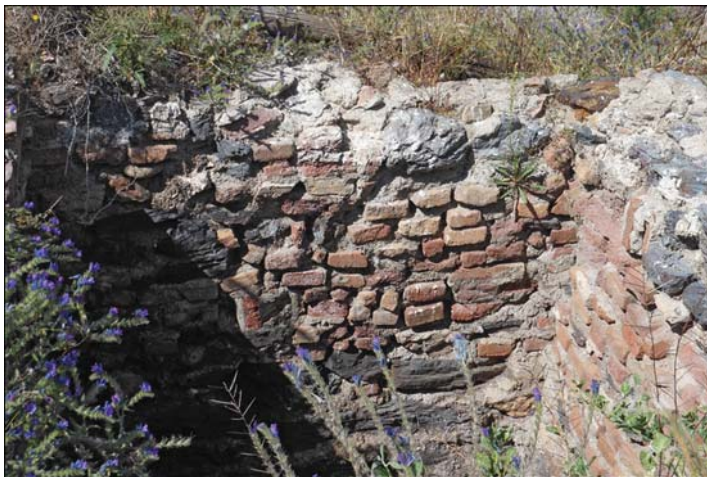
*The rough sides of the secondary shaft.*

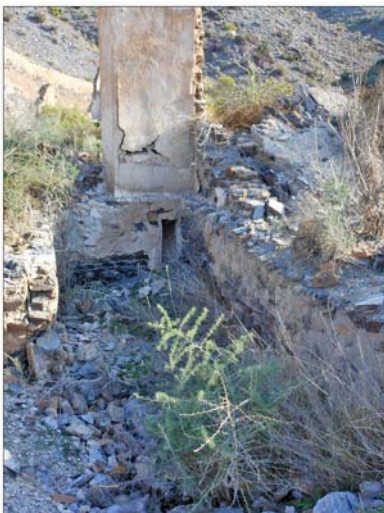
*The pit parallel to the shaft*

One thing which puzzled me about the site was the remains of the engine and pump room house. The pit where the fly wheel rotated is positioned parallel to the shaft and not at 90 degrees to it as one would expect.

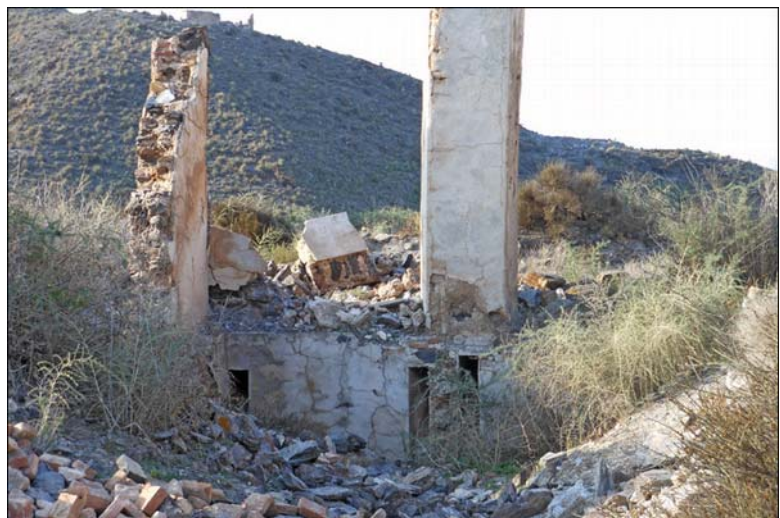
*Another view of the engine house.*

On further research, I found out why it was arranged in this way. The pump that was installed in 1884 was a Kley Pumping Engine, which, as can be seen from the diagram, needs to be positioned alongside the shaft.

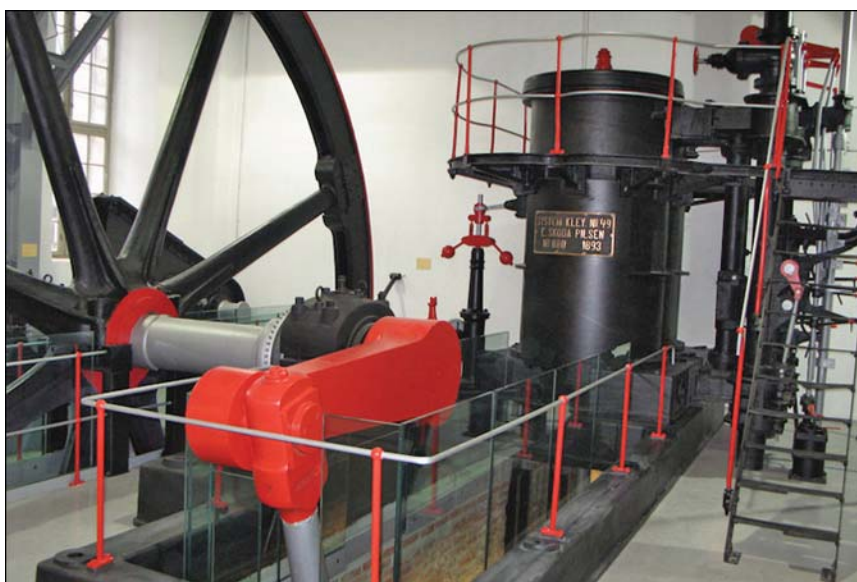
*Diagram of Kley pump*  
Henry Davey. 1900

*Restored Kley steam pump at the Idrija Museum.*

A Kley pump has been restored in Idrija, Slovenia. It began service in 1895 and was last operated in 1948. The one at San Juan operated for a mere 13 months, closing 3 days before the desagüe in the Jaroso. It was designed to lift water to a maximum of 221 metres, so was working at the limits of its capability in a 220 metre shaft. There was talk of pumping the water out through a drain lower down in the Barranco de Sima. However, in 1886, La Compañía de Águilas pulled the plug. In the case of both desagües, it was the mine owners refusal to pay for the very infrastructure they needed that sealed their fate. The mines were inundated and once more the industry was in crisis.

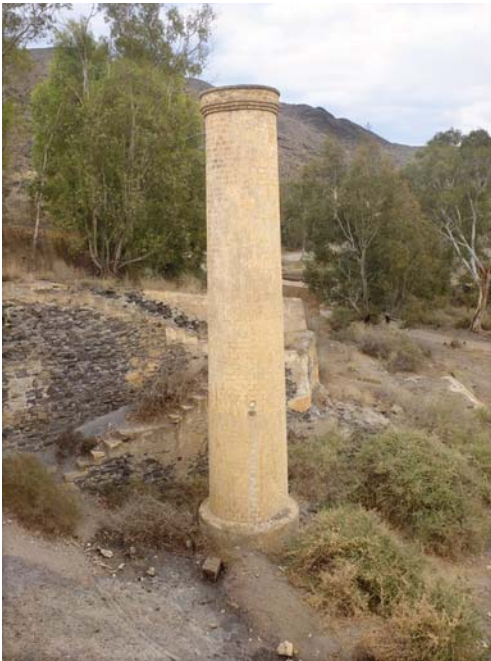
Left, Pozo Ana. The chimney above the shaft was added at a later date.

The downcast shaft, B, and the upcast shaft, C, were then excavated simultaneously. Because of their close proximity it was possible to ventilate one by means of the other, using 'holings' at intervals, then closing these openings later. The elliptical upcast shaft was named Pozo Ana and was sunk to a depth of 117 metres and served as the main ventilation shaft for Encarnación and the engine room. The circular, 120 metre downcast shaft, was known as Pozo Juala meaning cage shaft, because it was fitted with cages capable of bringing spopil wagons to the surface. The delivery shaft, D, up which the water was raised to the surface, was fitted with ladders in case of any failure of the winding gear in Encarnación or Juala.

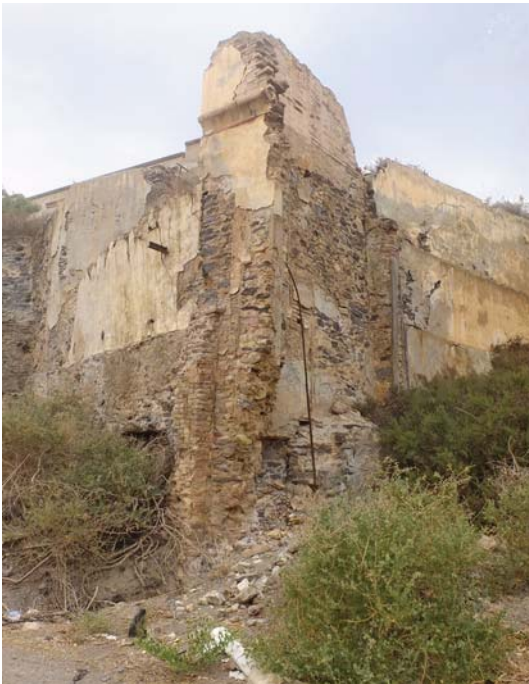
Right, diagram of the guide cables for Juala's cages. Reinhold.

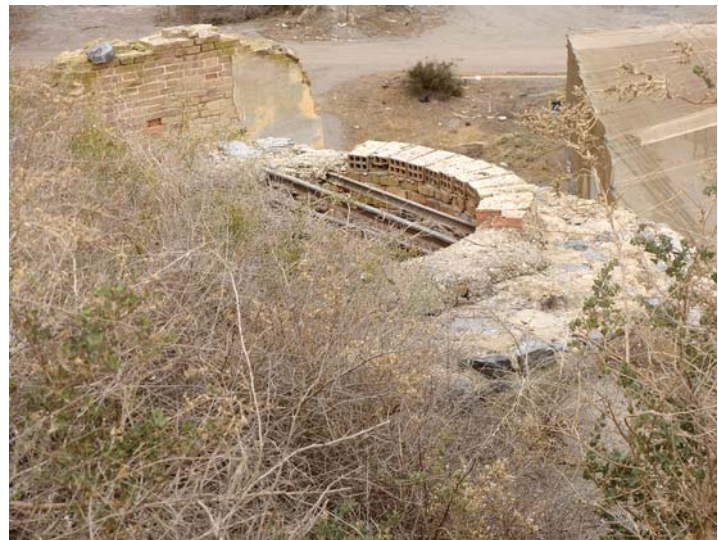
Left, back wall of Pozo Juala. This shaft has been remodelled many times over the years and is now completely sealed. Above, The top of the delivery shaft up which the water was piped to the surface.

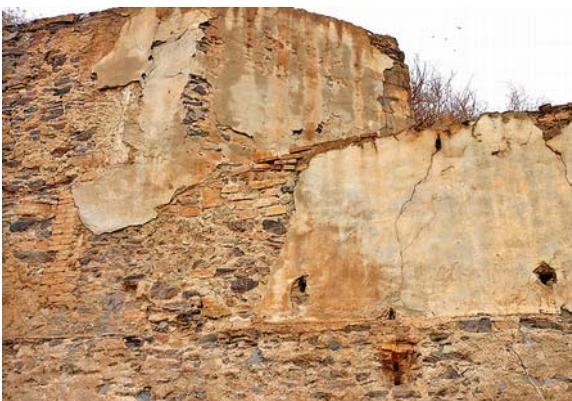
Above, the delivery shaft seen from below.

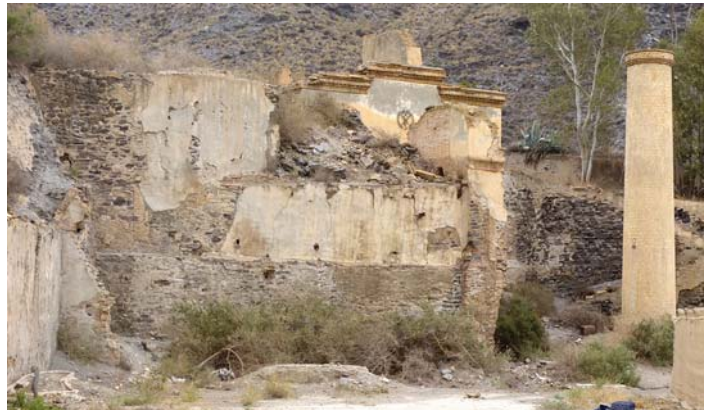
Above, all four shafts. The boiler room is on the left, the delivery shaft is above left, the remaining wall of Juala is in the centre with Encarnación above it and Ana on the right.

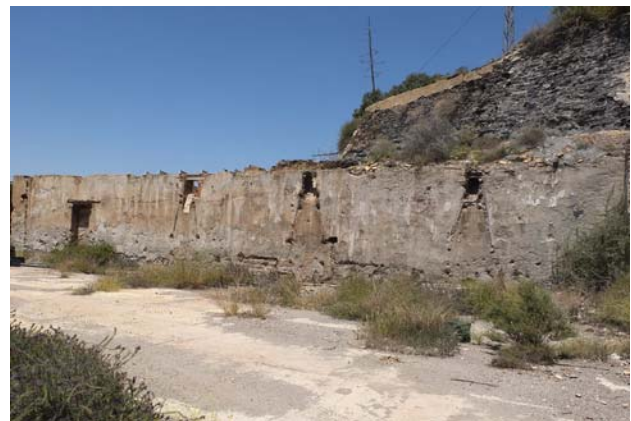
*Above right, the remains of the  
boiler house today.*

The power for all these works was provided by two Cornish style boilers, which were a temporary measure as the boiler house had been built to accommodate three larger boilers which were installed when the plant was ready to enter service.

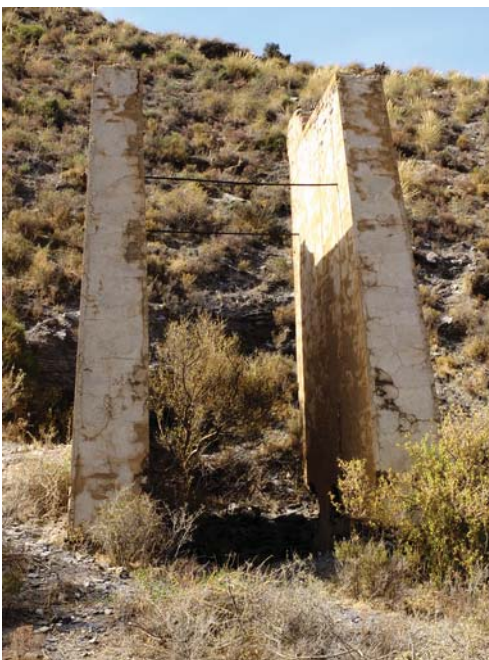
*Right, the ventilation shaft. The chimney was added C1903.*

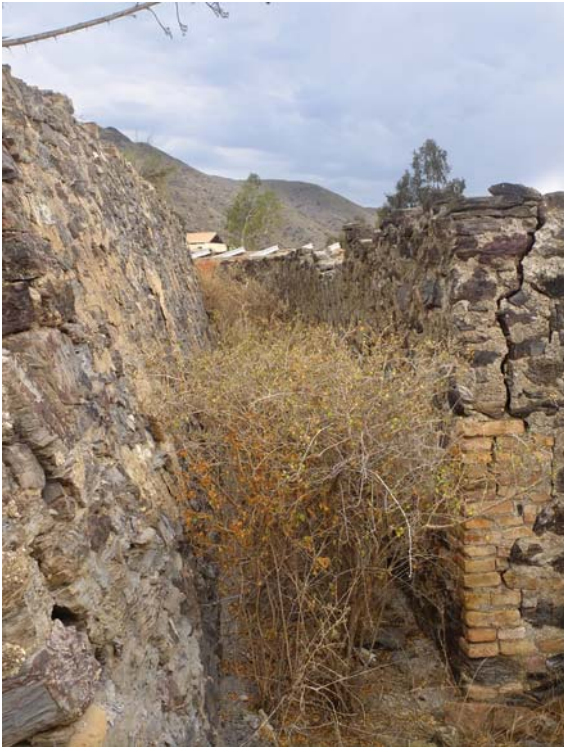
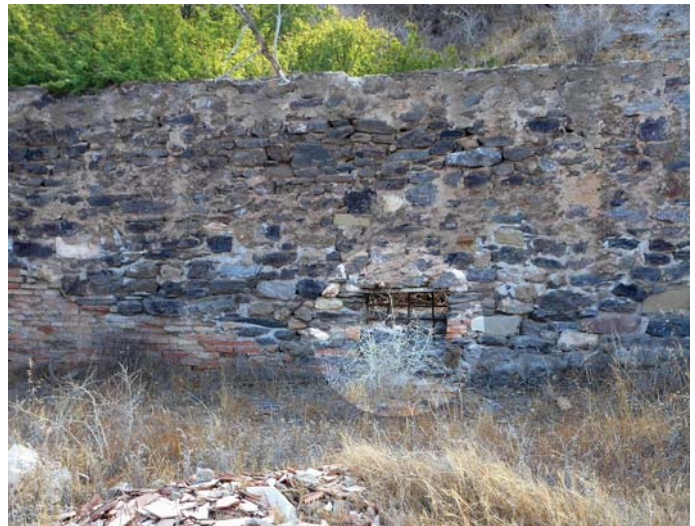
*Above. The water left the courtyard through the grille (highlighted).*

*Left. The pumped water flowed through the channel between the walls.*

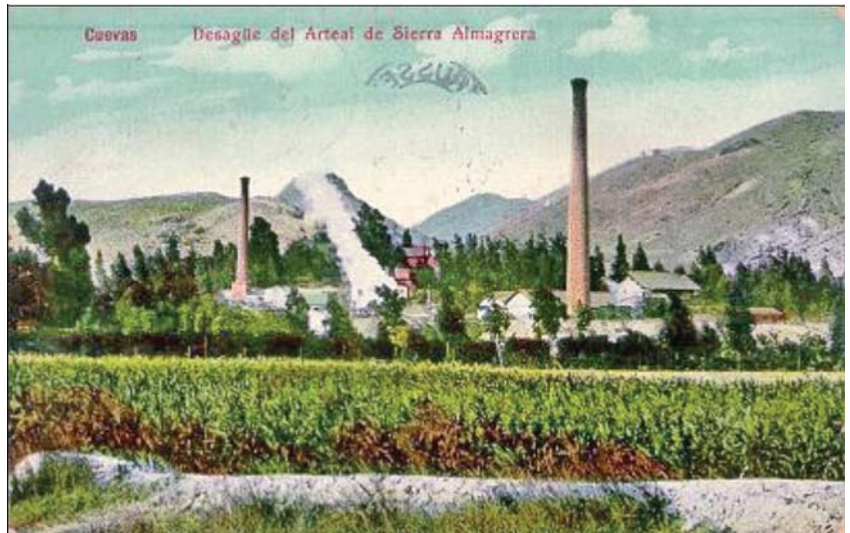
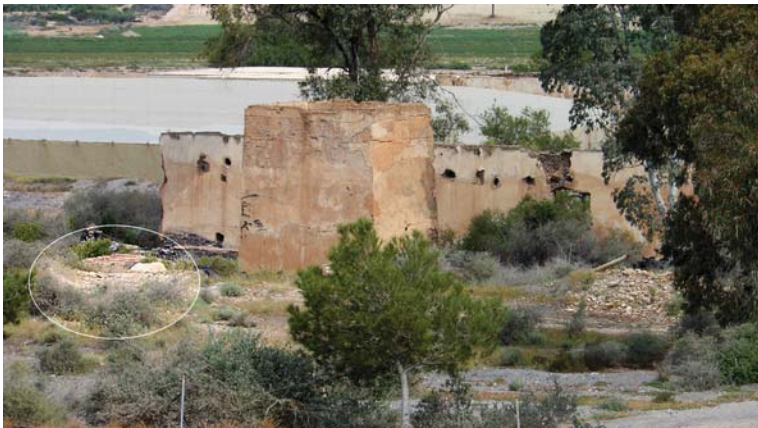
*Above, general view of the power plant. The base of the chimney on the left is highlighted and the boiler room wall is behind the water tower.*

*Right, the base of the chimney, in front of the water tower.*

A new power plant was built in order to run the new machinery. Sited 80 metres from the old one, it was three times the size. The boiler room had two banks of four condensing boilers from which the superheated steam was channelled through triple insulated pipes, over to and then down, Pozo Jaula to the machines underground. The feed water for the boilers went through a very complicated purification process (of which more in Volume 3) and the draw was provided by a 45 metres high chimney. Luis Siret’s railway was extended to El Arteal in order to bring coke, from the port at Villaricos. The line was carried, from the Rambla de Muleria to the site, along a raised pier and an embankment, and then crossed a bridge over the road to the Sierra. The bridge supports are still, just about, standing. The coke was stored in a huge, covered purpose built store next to the boiler-house.

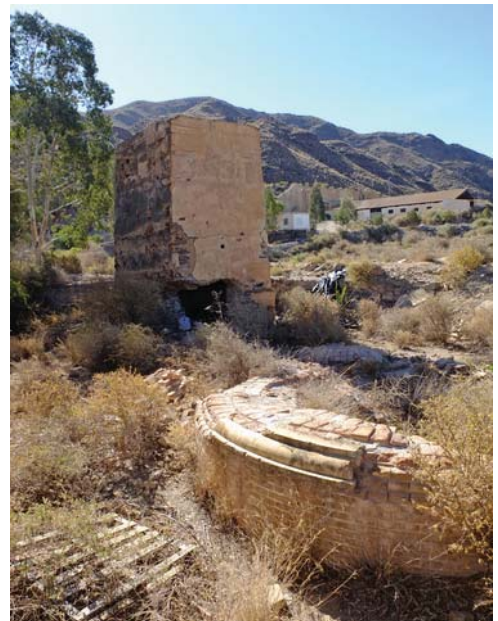
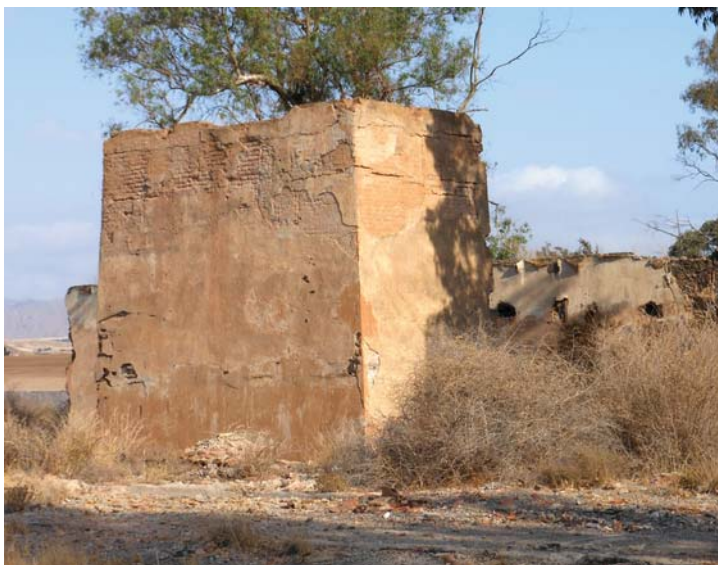
*The remains of the water tower. Tanks were situated on top of the tower.*

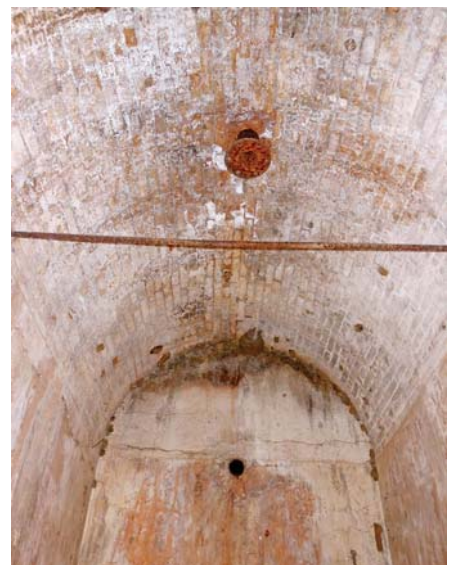
*Inside the water tower.*

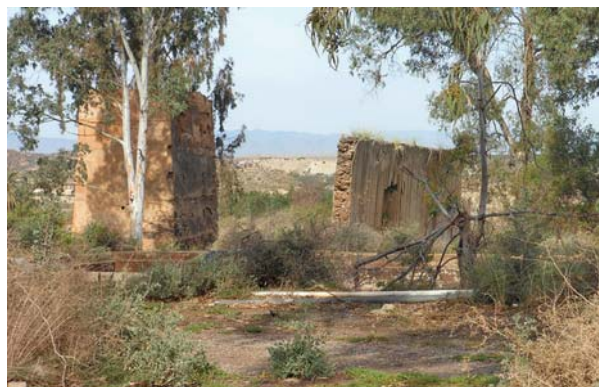
The picture below shows the water tower and the wall of the boiler house, but as can be seen from the plan, the building which housed the calderas, or boilers was a considerable size. The adjacent covered carbonera, or coal bunker, was large, but the one over the road from it was even larger. The former was used as settlement tanks in later years, while the latter is currently covered by greenhouses.

The view of the plant looking over the site of the covered coal yard.

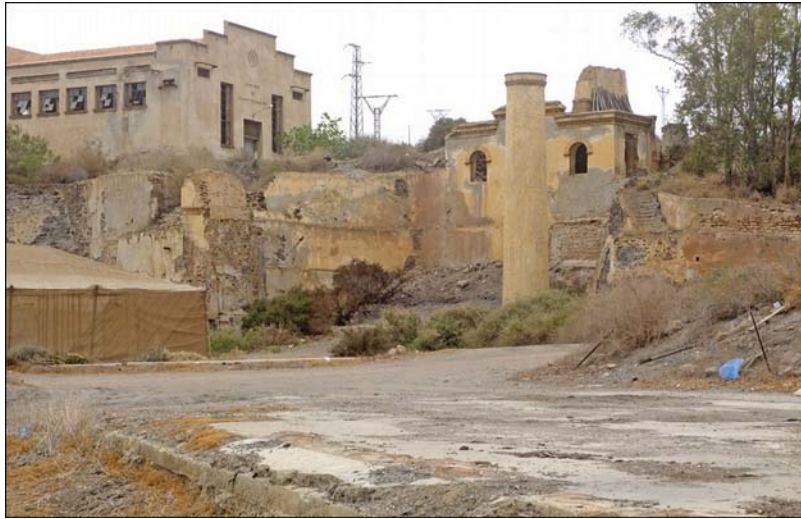
*Looking out over the workshops.*

The foundations of the workshops are in the foreground, then the chimney over Pozo Ana, with the building housing Pozo Encarnación behind that. To the left can be seen the back wall of the arched building which housed Pozo Jaula. The base of the delivery shaft is to the left, and slightly above, Pozo Jaula. Originally, the delivery shaft had a tall open-sided tower over it. Of the original chimney there is no trace, I suspect that the Central de Transformación was built over it. The old boiler house is situated behind the greenhouse on the left. As can be seen in the 1908 plan, to the original boiler house was added a carpenter's workshop, a machine shop, a patio, or open work area, and a store room. An abandoned, unlicensed, half-built house stands where the patio and storeroom were.

The forge and metal shop were to the right of the boiler house along with the bascule, or weighbridge. The foundations of the workshop are still there, possibly because they are too substantial to be worth the bother of digging them out. Nearby is a large concrete block which I think was part of the weighbridge.
