THEN, THERE WERE MINES

Volume
3

Chapter 1. Water, But Not Enough To Drink.

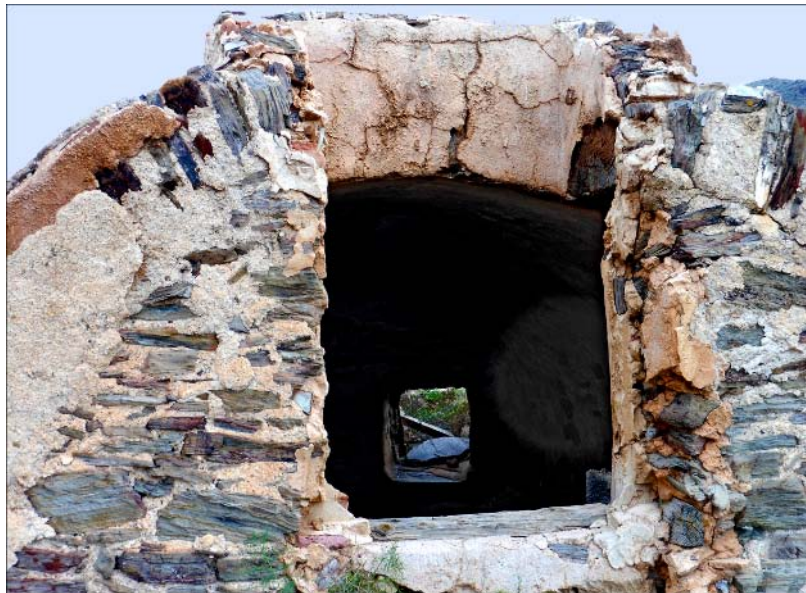
The boiler for the desagüe arrived in Villaricos in 1851 and was transported by a team of oxen. Sierra Almagrera y Herrerías. Bolea.

Low labour costs, small individual mines and good returns on extracted minerals, delayed the arrival of steam power in the Sierra Almagrera. While the desagüe had a steam driven pump as early as 1852, it was largely ineffective and unreliable.

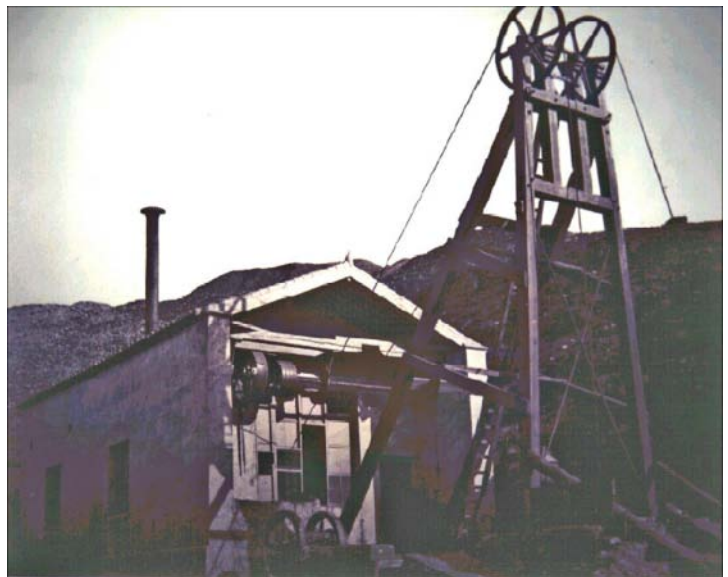
*... while the German firm, Humbolt, preferred a metal stack.
Both, Rodrigo.*

The engineer Paul Colson, responsible for 75% of the steam engines, favoured brick chimneys

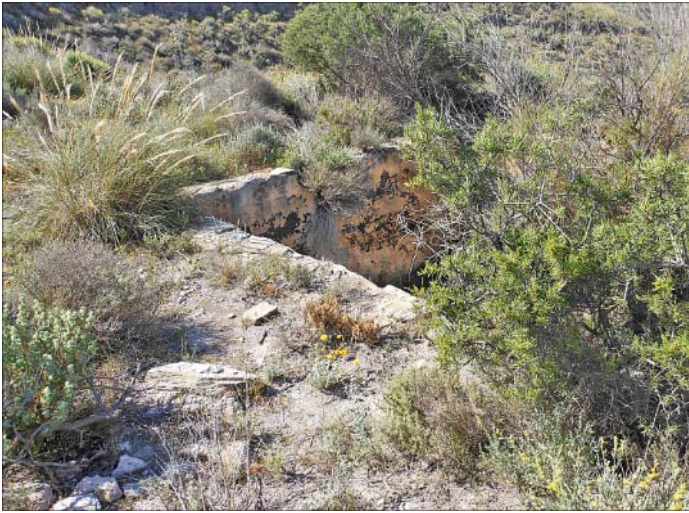
The simple balsa of the mine Ibería.

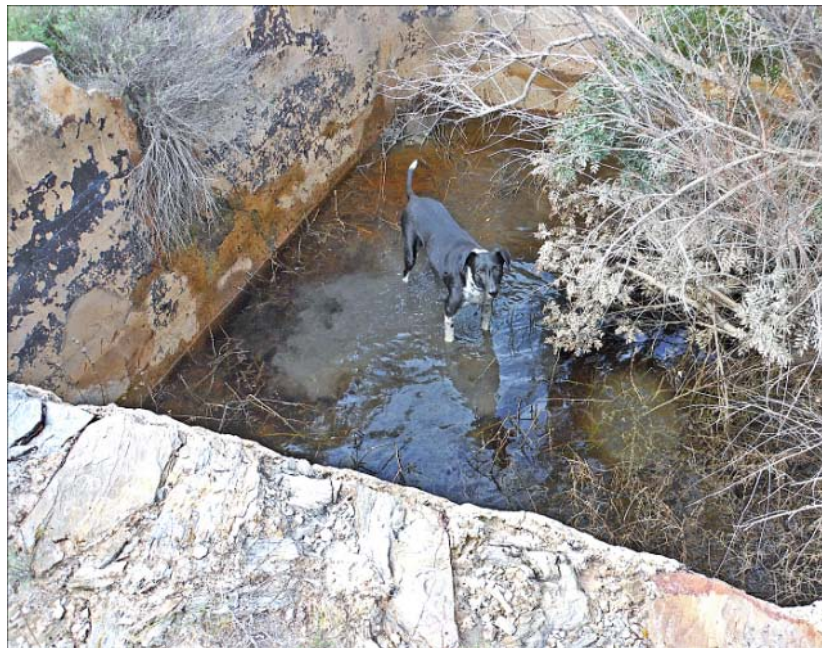
The balsa at mine La Ibería.

There are a variety of balsas in the Sierra, each easily recognizable. Any construction that has been rendered impermeable will have been used to contain and store water. Many of them are still capable of holding some water after nearly 100 years, as demonstrated by my canine companion, in the balsa of the mine La Ibería.

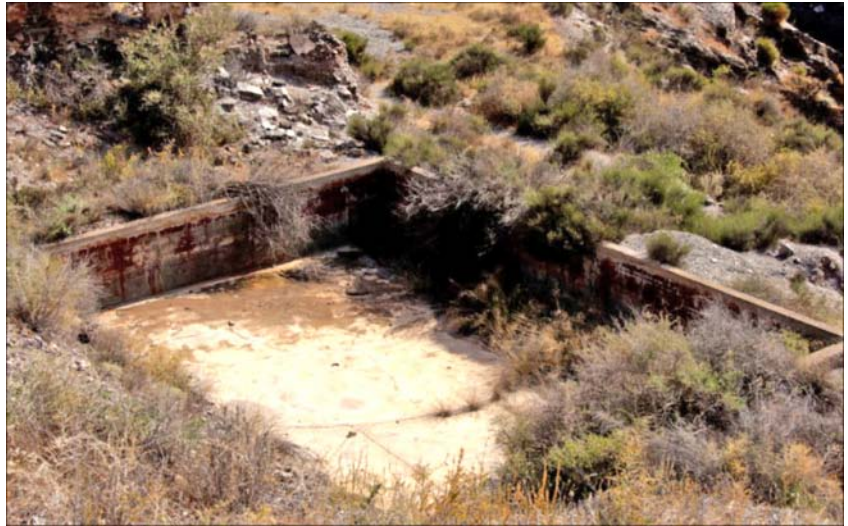
The shallow balsa of the mine Encarnación on the way up to the “Lost Village”.

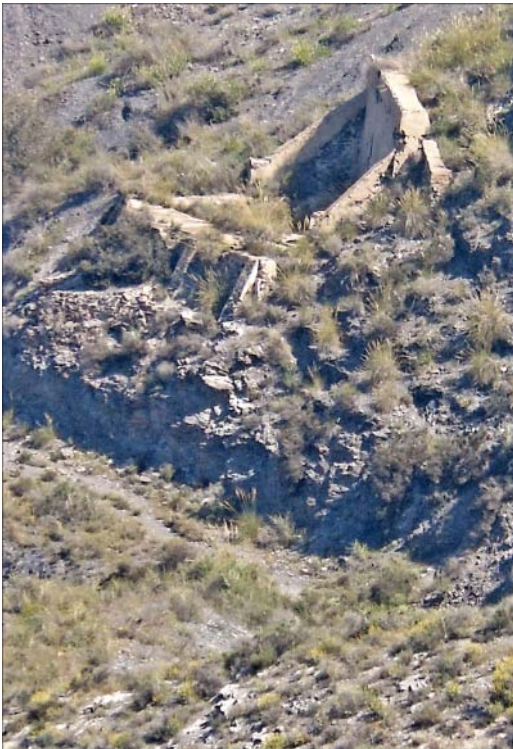
Two views of the balsa above the “Lost Village”.

As well as the type of balsa shown above there are at least two others. The first, above the lost village in the Barranco de Francés, has a high back wall, hard against the rock, and a tank at the front. A good view of this can be had from the Casa Dos Mundos promontory. Why they are constructed like this is a mystery to me. However, the design is still used in the present day. There is a massive, recently constructed example just outside Murcia.

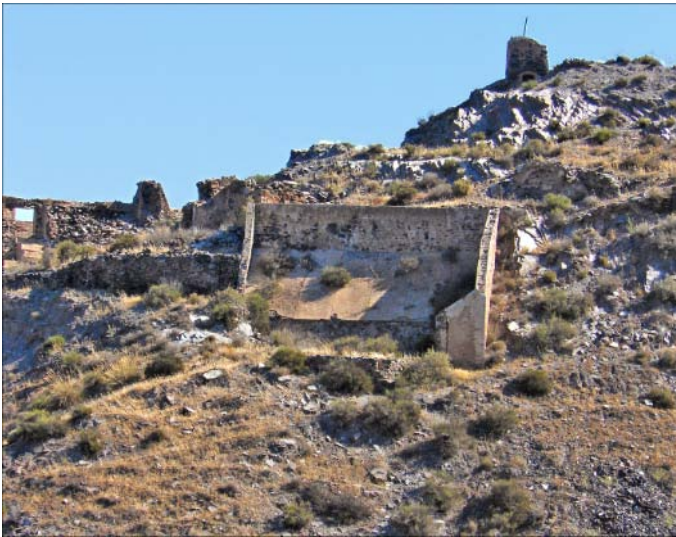
What looks like a balsa at the mine Ramo de Flores.

This structure was used for ore washing, but I'm not sure how it functioned.

What looks like another example of this type of balsa is at Ramo de Flores and is best seen when you approach the mine from the Barranco de las Palomas.

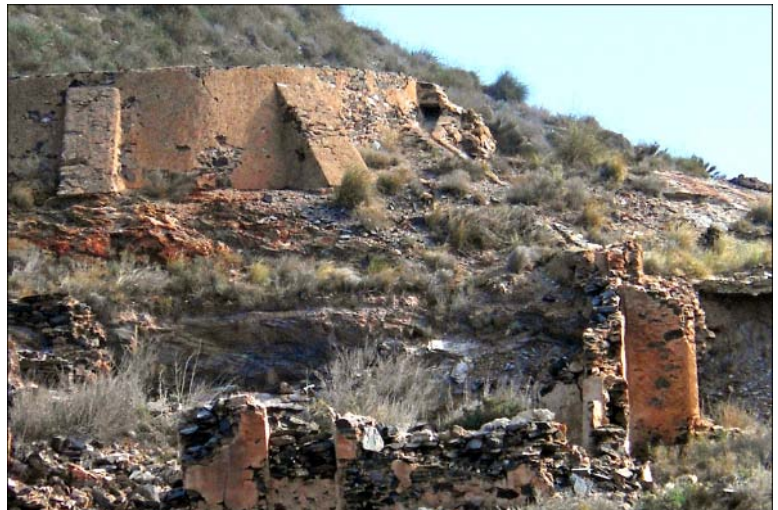
The unusual, circular balsa of the mine Venus Amante.

The mine Venus Amante, up by the Arab Watchtower, has a raised, circular balsa as well as the more usual sunken, rectangular type.

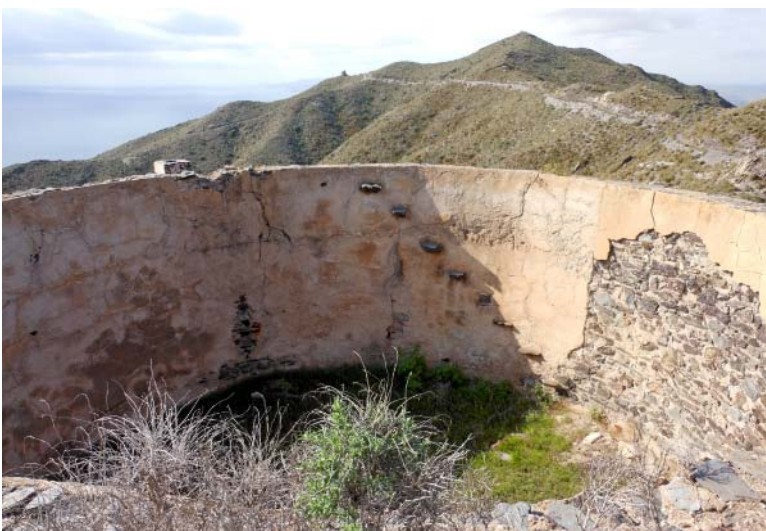
Looking inside the circular balsa.

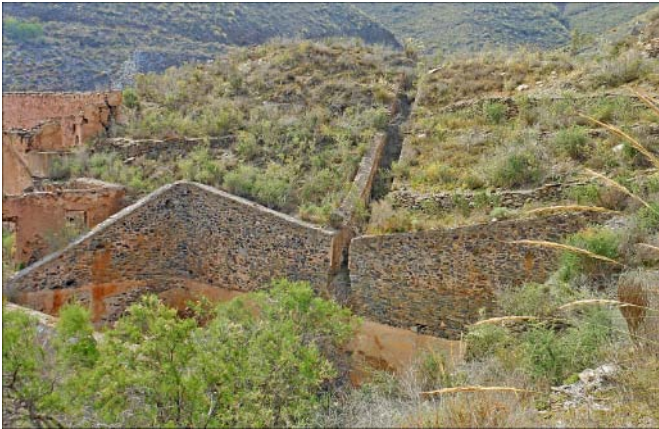
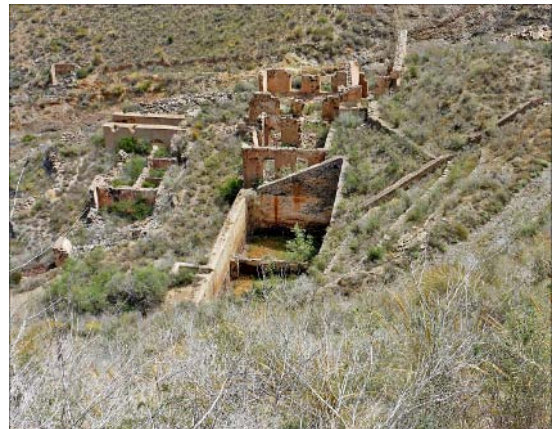
Two views of the Independiente's balsa showing the terracing and the feeder channel.

When it came to water collection and storage, it was, again, the men from Bilbao who were the masters. At the head of the Barranco Hospital de Tierra, the mines Independiente and La Guzman have the most striking water collection systems in the whole Sierra. Unlike the two previous types, these had roofs. The sheer size of the one that served the Independiente is quite breathtaking. The main feed channel was served by several terraces on either side.

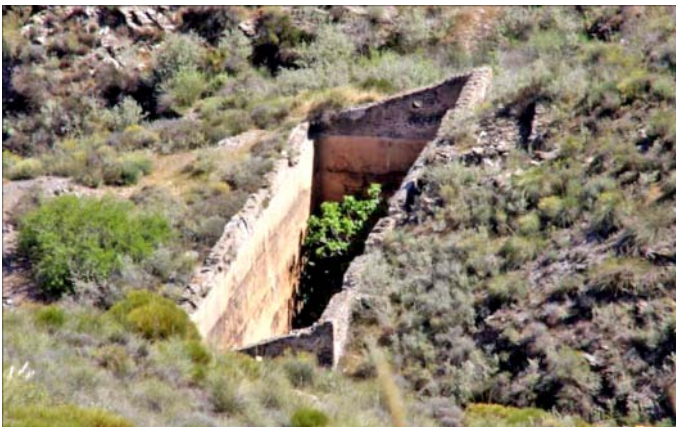
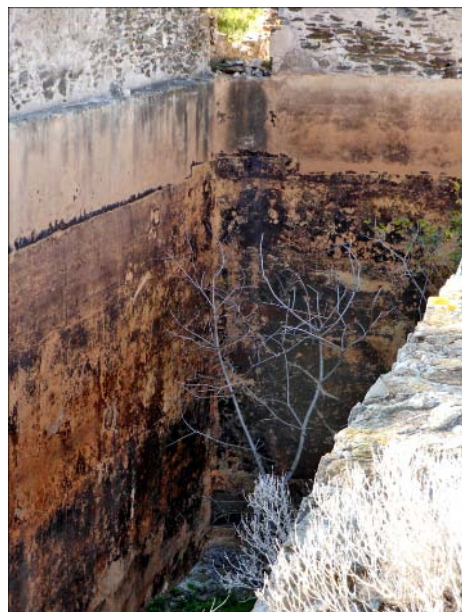
Two views of the Guzman balsa. To give some indication of size, I estimate its depth today to be about 7m. This is after a century of silt and rock being washed into it.

This massive 1500 cubic metre covered balsa was fed by a water collection, or captation system that extended right up the valley and comprised of a series of dams and smaller balsas. In addition, surface water from the surrounding hills was channelled into the system via a small aqueduct and a series of small canals, which extended away from the balsa for a considerable distance.

However, even the Independiente's system pales into insignificance when one looks at that of La Guzman which was built in 1880, when the steam engine was installed.

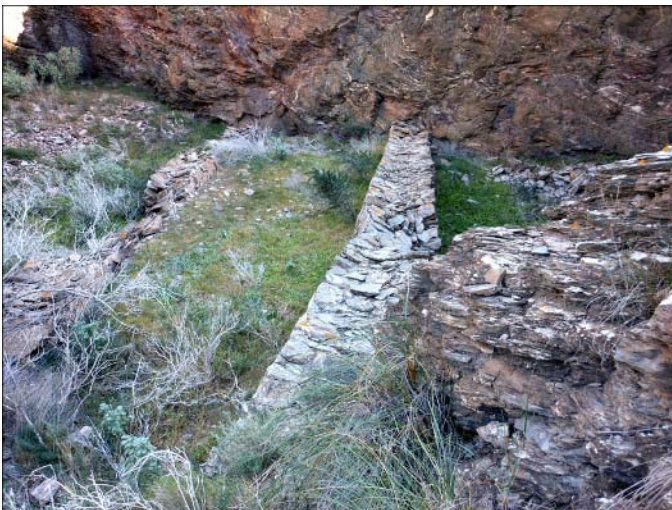
The intermediate balsa had sluice gates which could be closed when necessary, allowing water to collect on either side of a low, raised wall. The wall has a depression along its length, and looks as if a pipe ran along it. I think that it carried water from the dam above it towards the main balsa. There are several small sluice gates along the way, where water could be diverted away from the balsa and onto the ore washing floor.

Above, the low wall used to conduct the water.

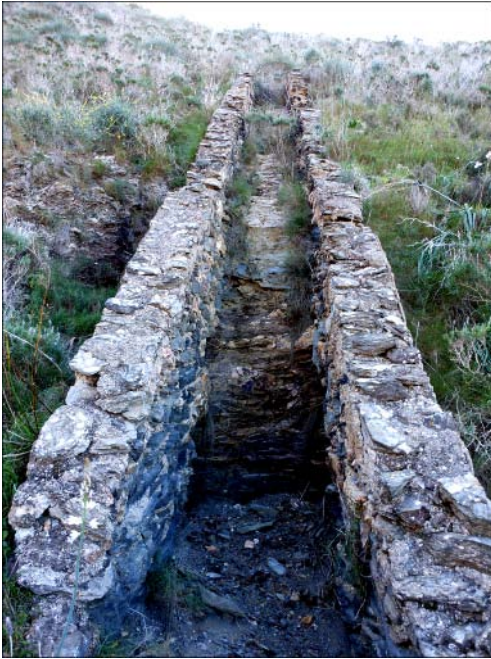
*One of the channels used to collect water on the hillside.
These used to be covered.*

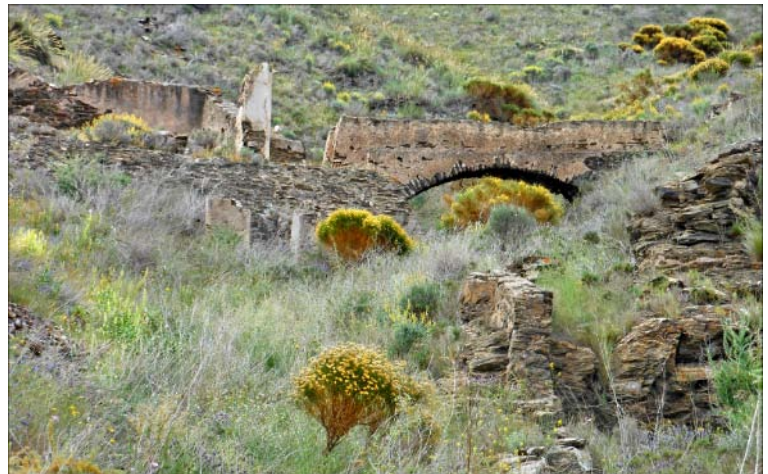
This aqueduct carried water channelled from the neighbouring hillside.

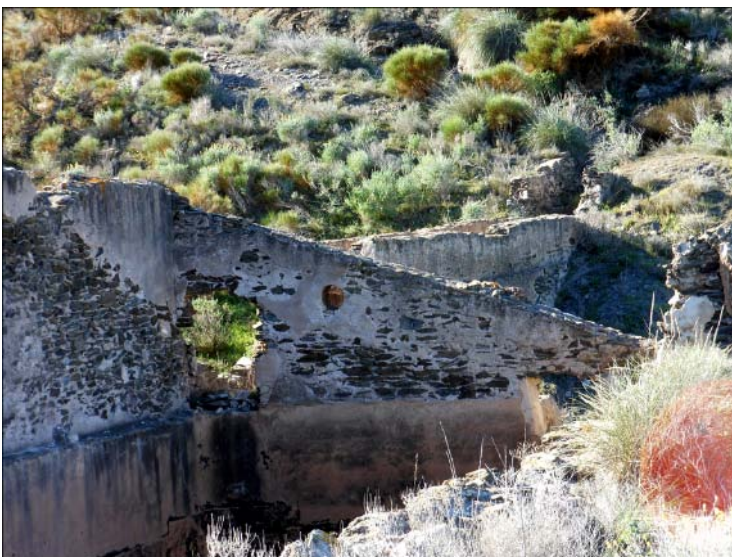
Water from one slope entered the balsa at this end via the aqueduct.

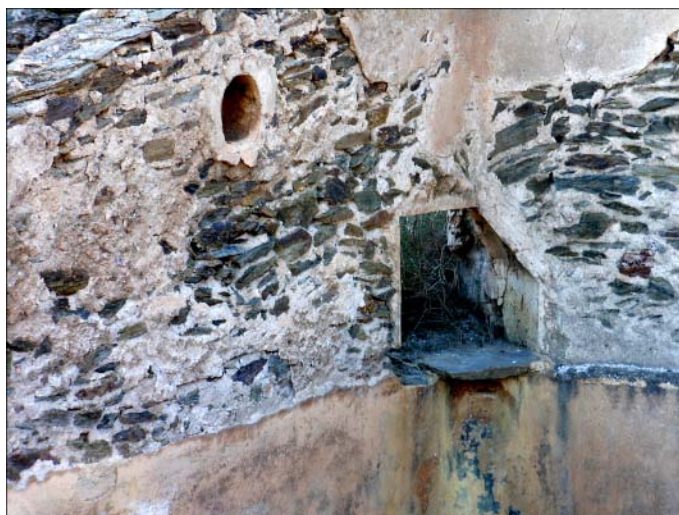
Water from the channels on the other hillsides entered at this end.

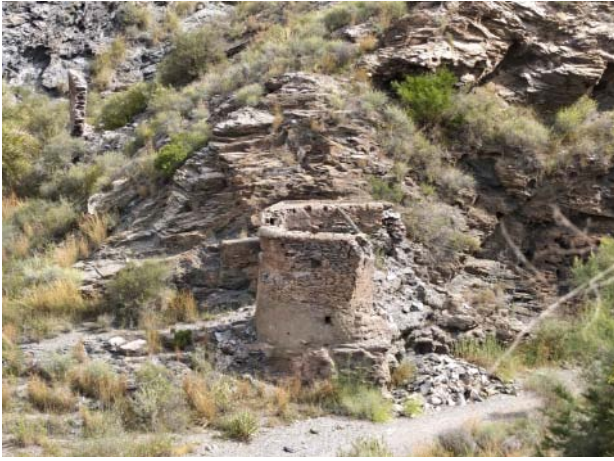
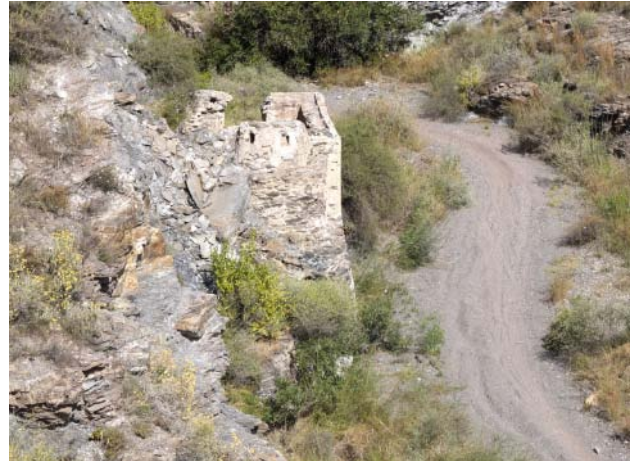
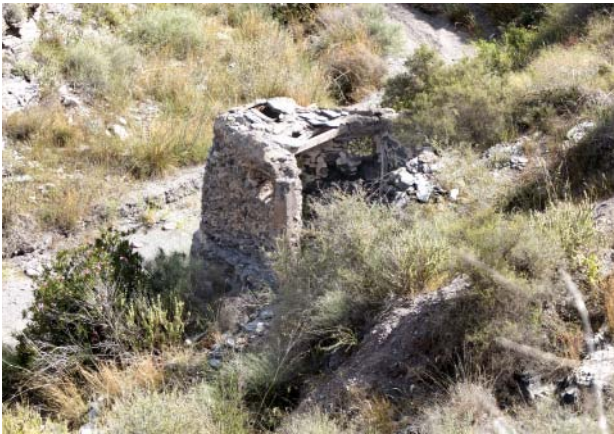
The remains of the ancient wells.

Although there was a higher annual rainfall in this part of Spain in the 19th and 20th Centuries, water was always in short supply. Before the mining boom, the only local supply came from ancient wells in the Barranco de los Guardos, in the section where it runs parallel to the A332, Los Lobos to Pozo del Esparto road. The remains of some of these wells can be seen from the steam-roller lay-by

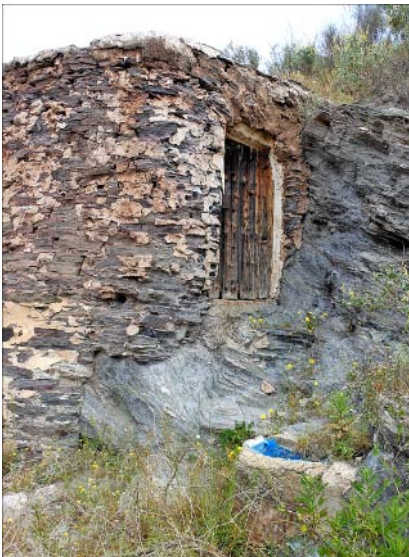
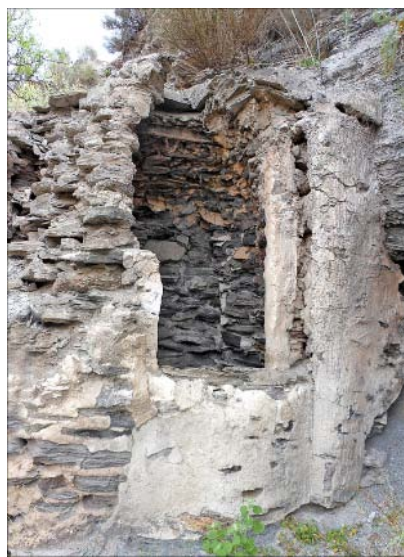
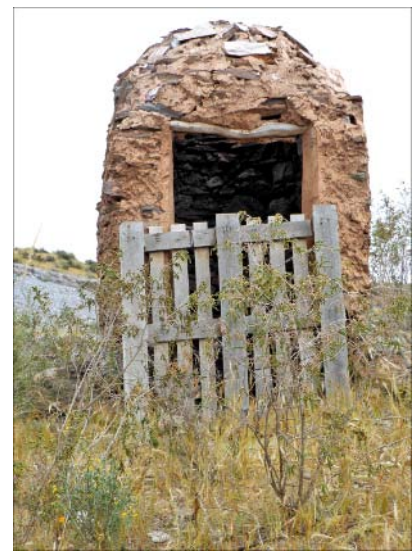
Some of the newer wells at the Boca de Mairena.

These few wells were unable to meet the demands of the growing mining industry and new sources of water were looked for. Several wells were sunk at the Boca de Mairena near to where the Barranco de Mairena and the Barranco de Granadinos converge. These provided a good source of water, as did wells sunk along the banks of the Rambla de Muleria and at El Tomillar.

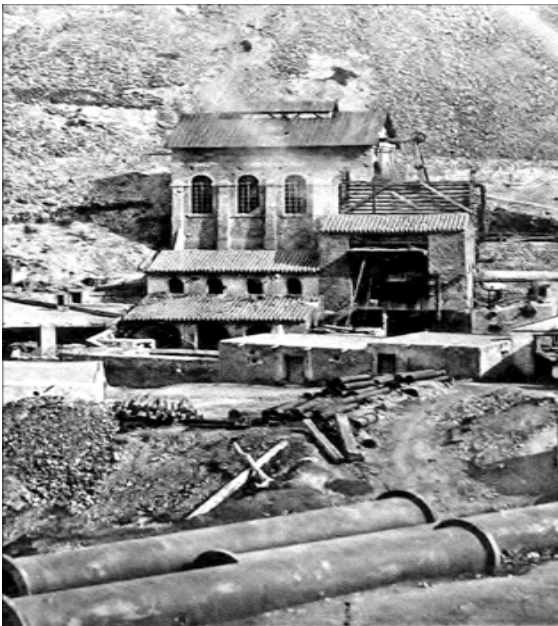
The desagüe in 1875. The original pumping engine was housed in the building to the front-right of the tall, later to be, engine house.

The beam and fence-like condensation pipes of the new engine can be seen above the old engine house.

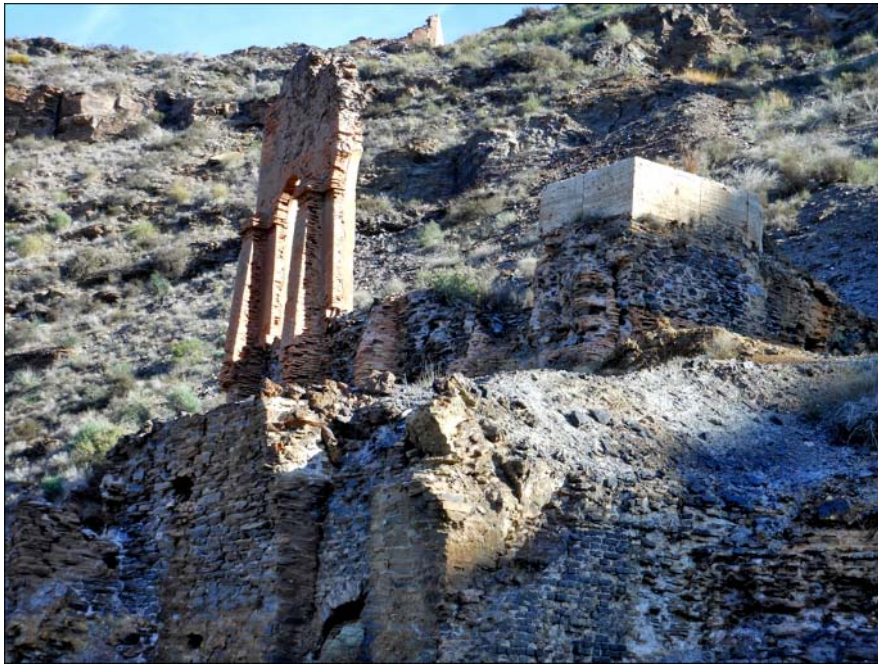
All that remains of the Desagüe del Jaroso today. The stonework to the centre-left of the picture is the first window in the above 1875 photo.

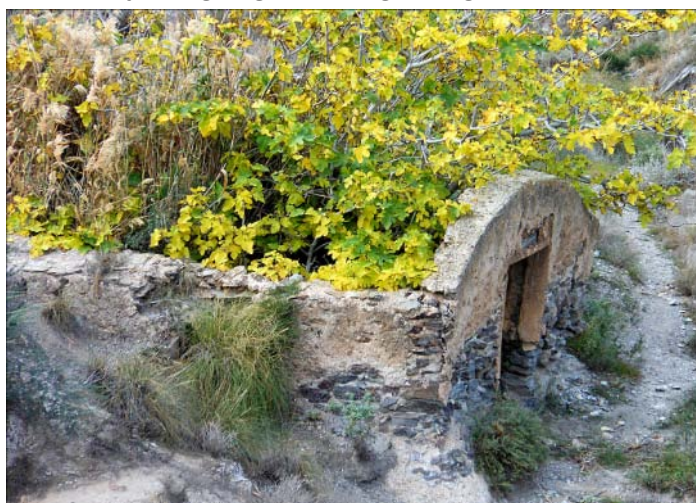
The remains of the aljibe in the Barranco de las Palomas, probably serving the mine Rosetón.

Like so many things in the Sierra, this one was puzzling. What had happened to its roof? By the shape of the remaining end wall, it obviously been barrel vaulted one, so where is it?

A roof of this type is an extremely strong, stable structure, which has the advantage of keeping the internal space cool and of minimizing water loss by evaporation. They were constructed using a series of arched, wooden formers. Over these, large stone slabs were arranged like segments of an arc with the slabs dovetailing into the next arc. The spaces between these large stones were filled with smaller rocks and stones and the formers removed. The whole thing was then mortared.

One possibility is that it was abandoned before it was finished. (The mortar at the top of the up-stand is very smooth.) Another possibility is that the roof was constructed of brick. If that was the case, then they could have been recycled when the aljibe fell out of use.

Another mystery of this aljibe is where the water is collected from. It appears to come directly from the rock at the end of the structure. There is nearly always water and mud in there which the dogs find. I have never ventured into it. For one thing it is very overgrown and the other is, that while it looks to be fully silted up, I am mindful that the tank in an aljibe is quite deep.

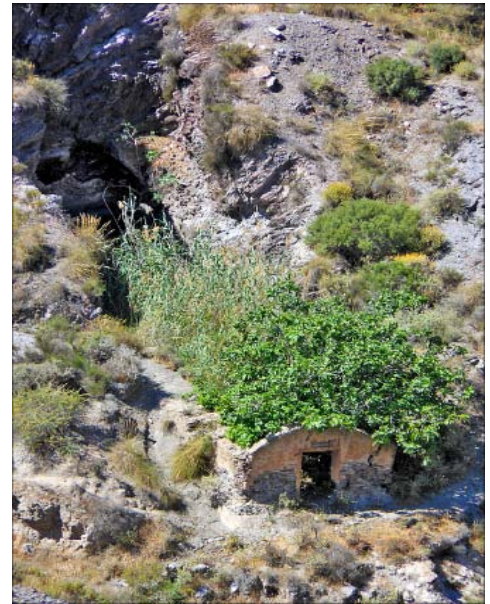
The rear of the aljibe is overgrown and silted making it impossible to work out where the water came from and how it was collected.

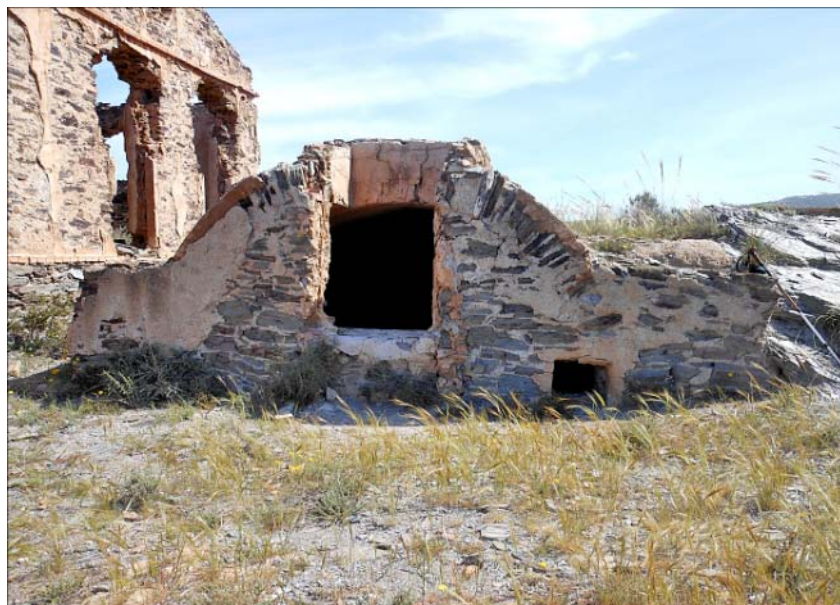
The aljibe at Casa Dos Mundos

This one is in an extremely good state of preservation. It used to have a rectangular tower at the head, where the pulley and bucket were housed and would have looked similar to the one pictured below. The small aperture next to the extraction opening is the overflow from the main tank. The construction method of the roof is very clearly visible. This roof was reinforced by the two solid buttresses at either side.

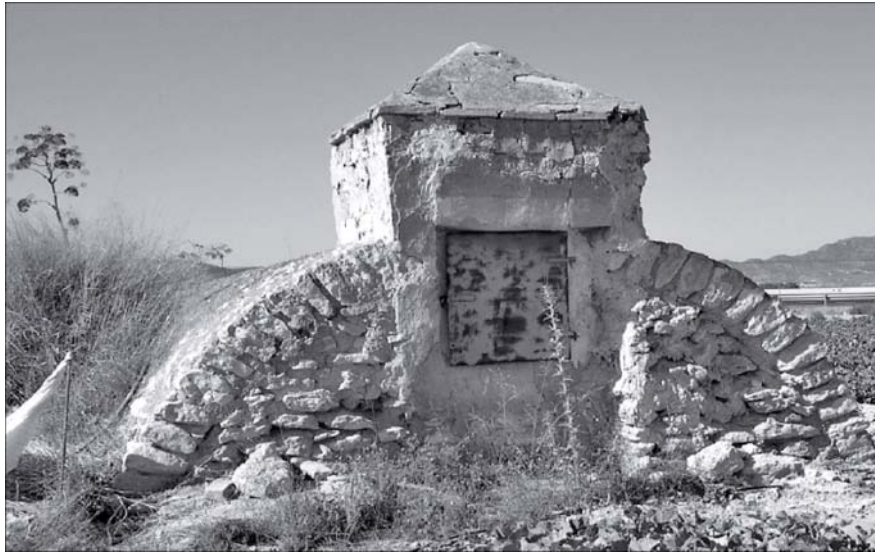
What the aljibe's tower probably looked like. Blanco, Bermudéz and Boti.

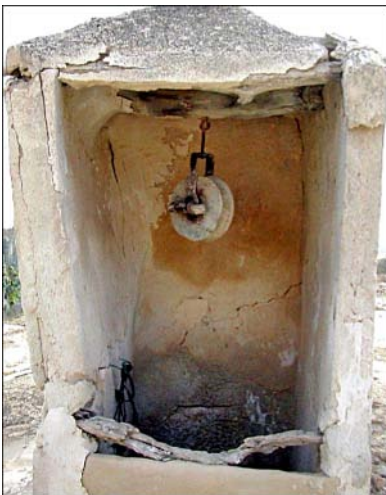
The bucket & pulley system inside the tower may have looked similar to this.

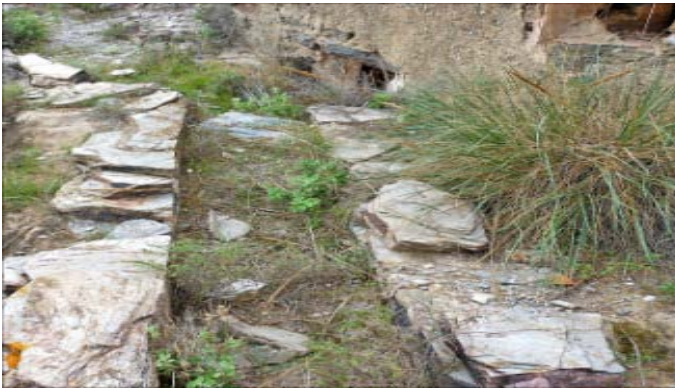
The roof run-off channel enters directly into the cistern.

At the rear of the Dos Mundos aljibe are two, dry-stone, gullies. One served to channel the rain water from the roof of the massive, adjacent building, while the other channels the water that has passed via the sedimentation tank.

In both cases the water entered the aljibe through the small opening. The roof run-off water didn't pass into the sedimentation tank, probably because there was so little debris in it. The usual practice in such cases was to use brush wood, placed in the channel, which acted like a mesh trapping any loose organic matter.

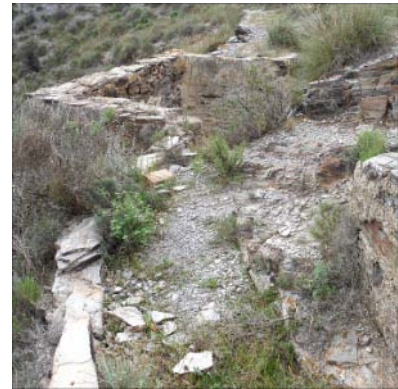
The run-in via the decantation tank.

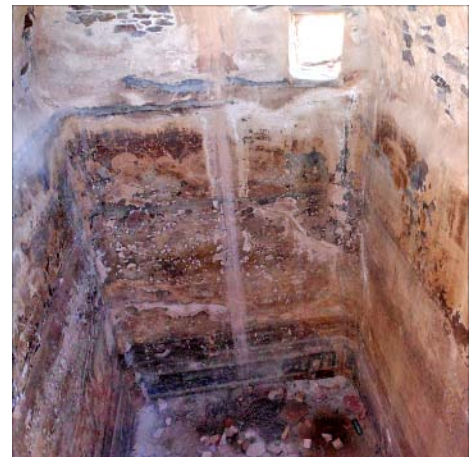
The interior view of the cistern of the Casa Dos Mundos aljibe.

The aljibe of the Ibería mine.

The main cistern of this aljibe is quite deep, and the various water levels have left their tide marks. Aljibes and balsas were rendered impermeable with what is known as “argamasa” which is a mix of lime, sand and water. It is evidently very effective since many of these structures still hold water. Apparently, in the absence of lime, a mixture of soot and urine was used instead.

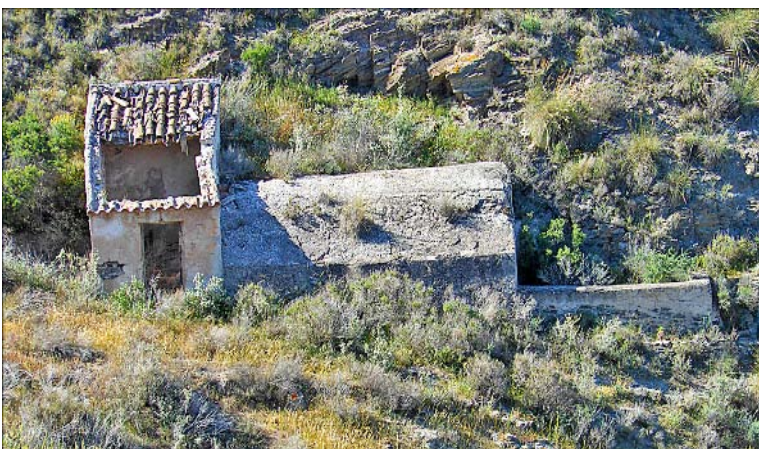
Slightly different in form, the aljibe of the La Ibería mine also is in quite a good state of preservation. Here, the water was extracted via a well-like hole situated in the lean-to structure. Again, here is a mystery. The extraction hole is situated just inside the entrance of this lean-to which leaves a substantial amount of free space between it and the back wall.

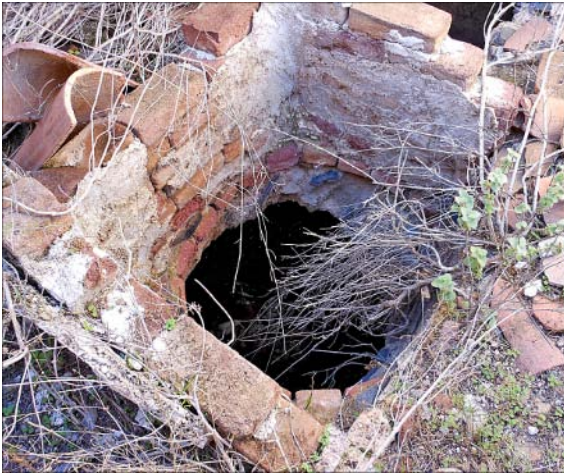
The “well-hole” of the aljibe.

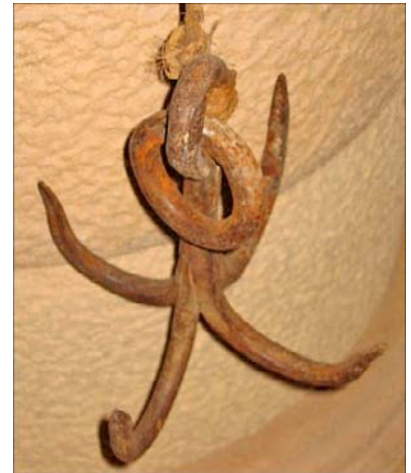
The bucket hooks often used in aljibes. The design allowed them to be tipped without spilling any water.

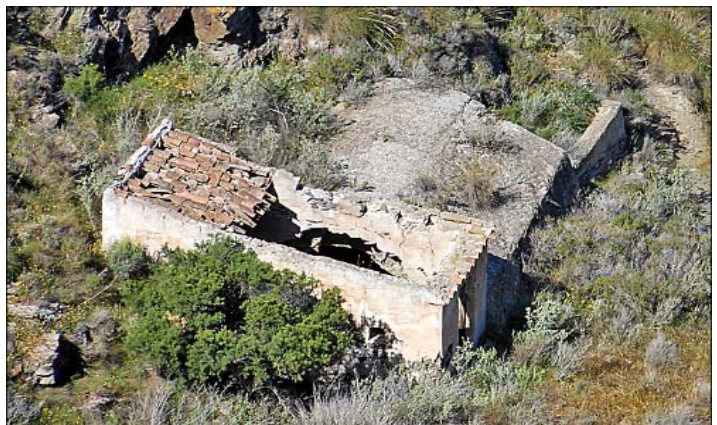
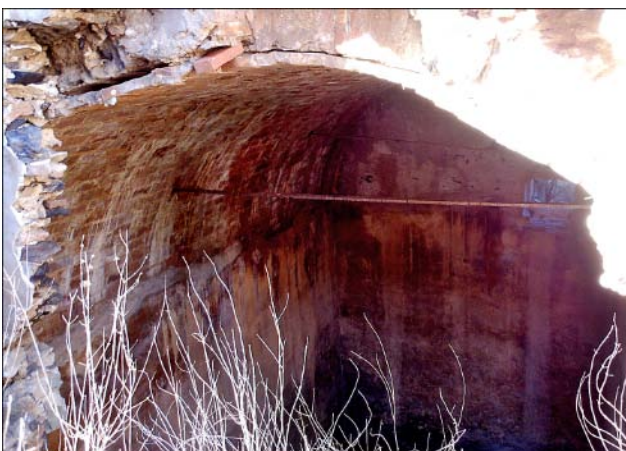
A different view of the aljibe showing the extent of the “lean-to”.

This aljibe draws its water from the run off from the hill behind and to the side of it avoiding the contaminated hill opposite. A short channel leads to the sedimentation tank and then to the aljibe itself. The roof of this one has been brick lined, although it looks as if there is also a stone covering. The overflow was collected and stored in a small balsa at the end of the main cistern.

The roof of the aljibe is brick-lined and, possibly, constructed of stone.

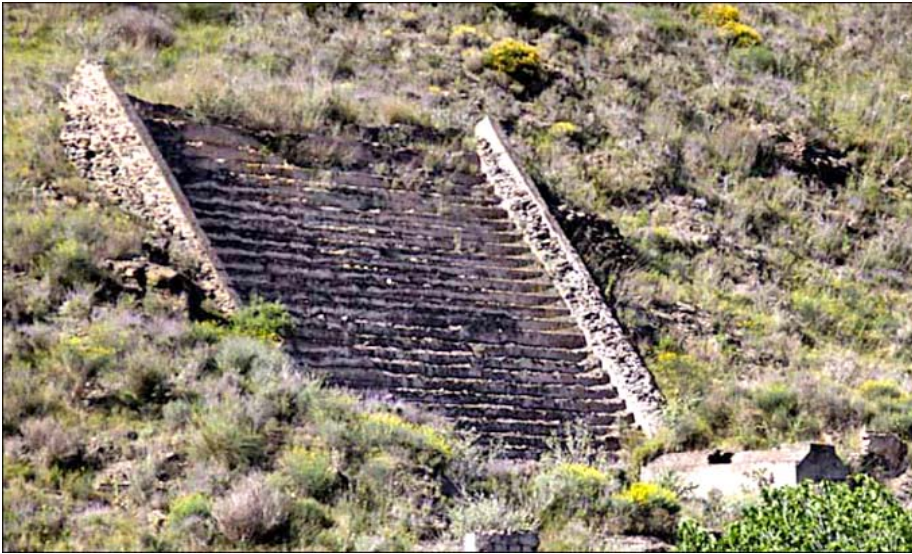
The aljibe at the mine La Guzman is situated at the bottom right of the picture below.

The water was extracted from an opening at the front where there was a small tower, similar to the one at Casa Dos Mundos. The opening in the central section of the vaulted roof of the cistern is where it has partially collapsed.

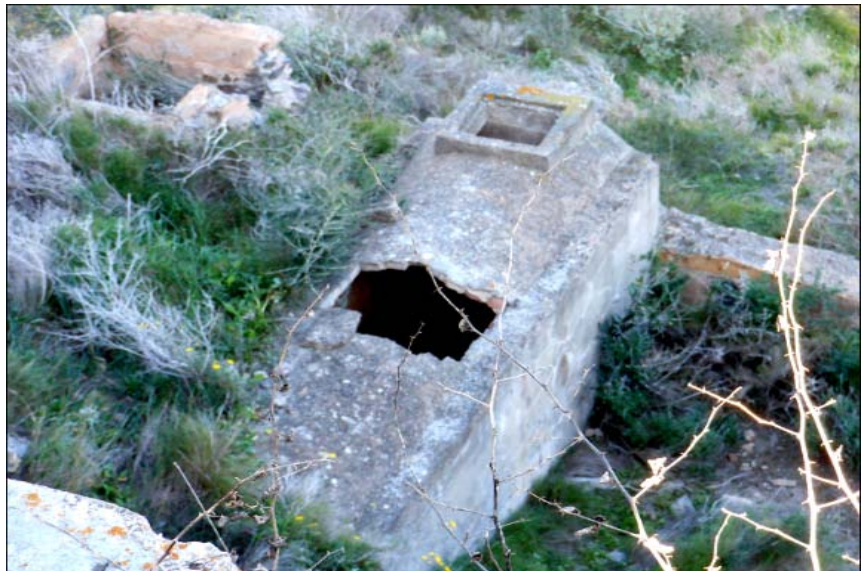
The collapse can be clearly seen from the top of the stepped structure. It looks as if it has been struck with something.

I had a theory about what looks like a flight of steps. I thought that it was to compensate for the steepness of the slope leading to the aljibe. The steps serving as both a water channel and a sedimentation system, with any mud, stones or organic material being deposited in the small troughs present on each “step”. Any build up of sediment could easily have been removed between rain storms. In the event of the “steps” being unable to cope with the amount of water, the flow could be diverted, along with any overflow from the aljibe, via a series of terraces into a large balsa situated on the level of the engine room. Antonio Jódar disagrees with me, believing that it was an ore washing system which functioned as per my theory. I shall revisit La Guzman and look for a decantation cistern for the aljibe. If I find one then I was wrong, but I want to believe that I am correct. (Fingers Crossed!) There is, of course, the possibility that we are both correct, and there was originally a partition down the ‘steps’.

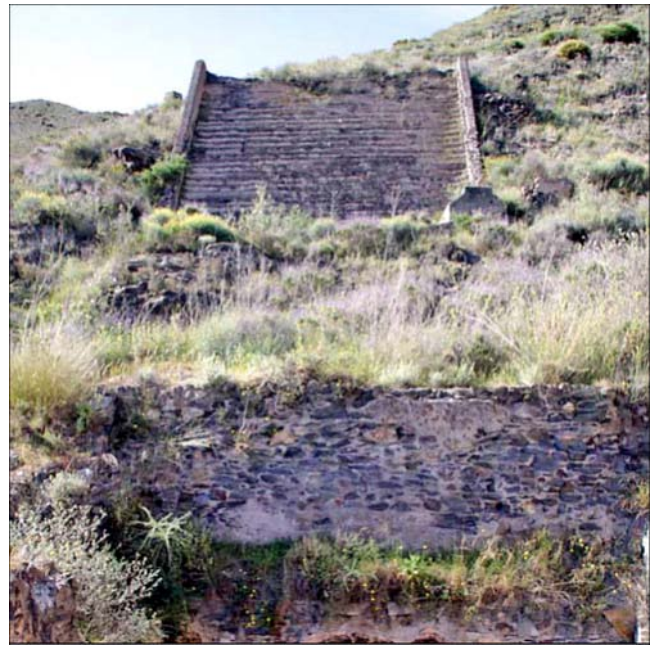
The terracing into the lower balsa, below the “steps” and the aljibe

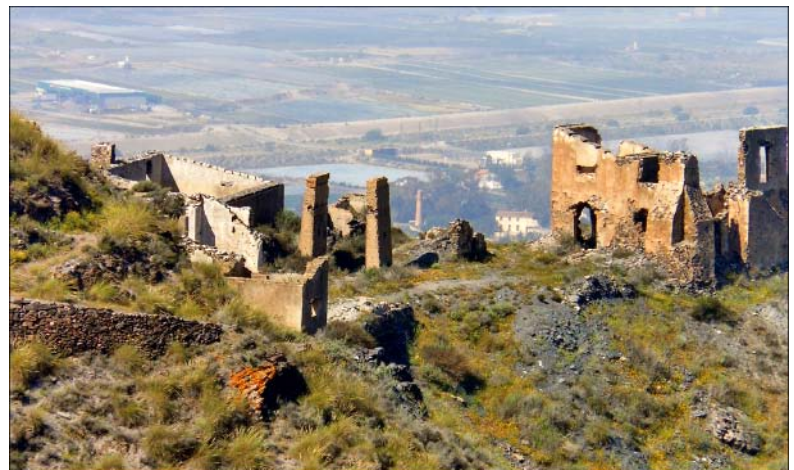
The aljibe is to the left of the two pillars in the centre of the picture.

There is one very non-traditional aljibe that I have found. It is situated between the Las Palomas and the Dos Mundos ones, at the mine Ramo de Flores.

This one is not fully sunk into the rock, but rather was built up. It is rectangular in form and had a sloping, tiled roof.

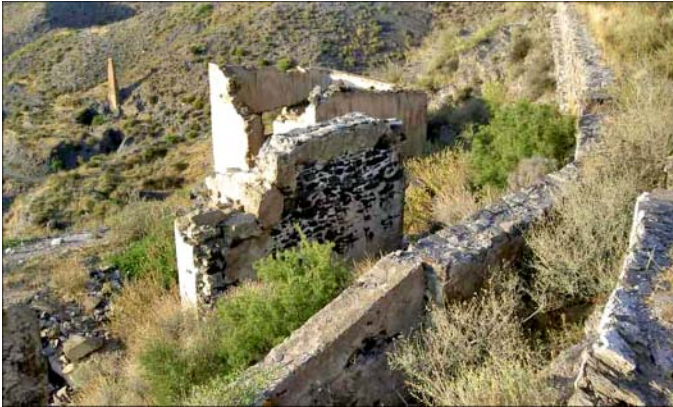
The water channel leading to the sedimentation tank.

A piece of slate placed at the end of the channel serves as in inlet pipe.

The water was collected from the top of the mountain behind the mine and channelled, via a small sedimentation tank into the cistern.

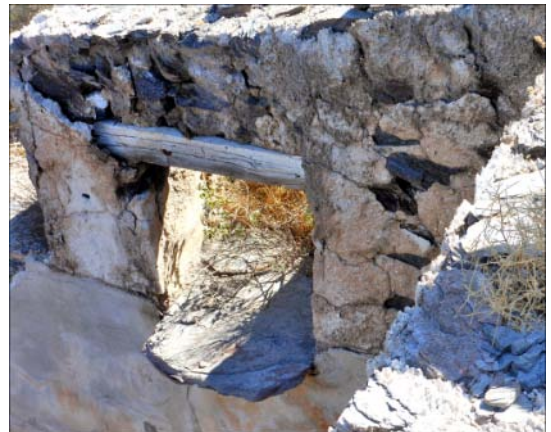
A shaped slate made a good inlet pipe.

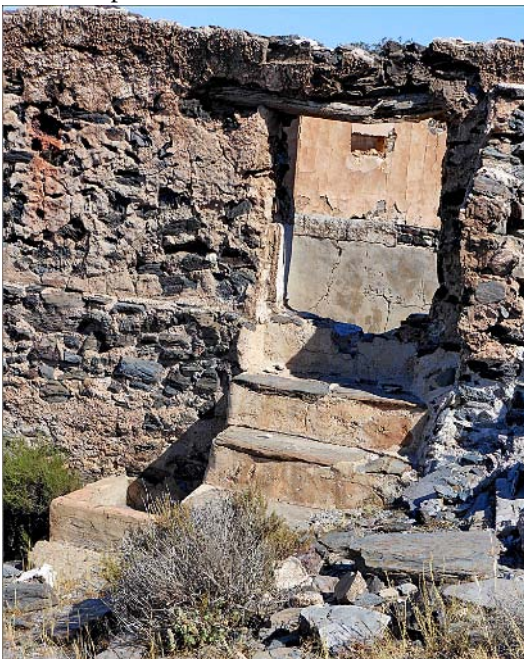
There is something about this small flight of worn steps, so human in scale, that evokes the spirits of a century ago.

The water was extracted via the small flight of steps situated at the back of the structure where the stone sink is still in place.

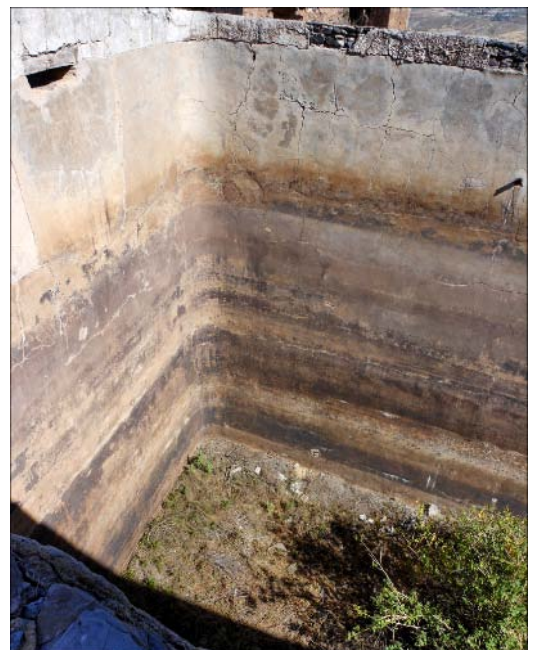
The "tide-marks" in the cistern recording periods of wet weather remind me of the rings in a tree trunk.

The rendering inside the cistern (previous page) is in amazing condition and the “tide marks” can still be seen. Any overspill from the aljibe was channelled down to the balsa situated on the slopes below.

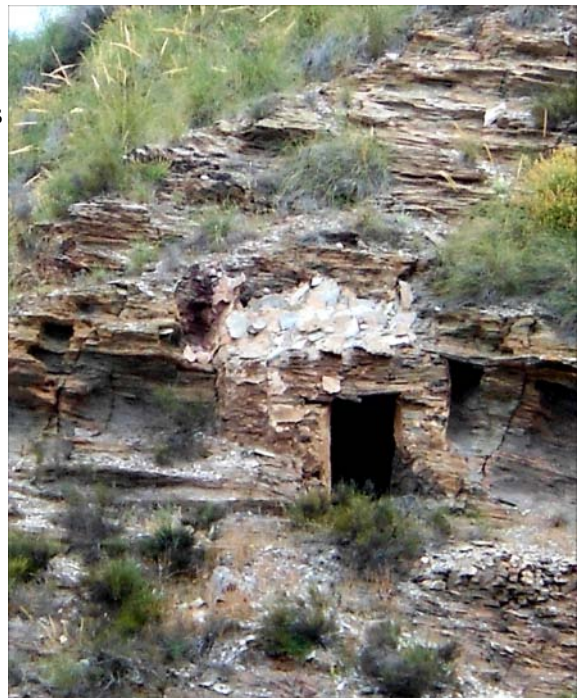
The polvorín of the mine Ánimas in the Jaroso valley.

Not all polvorínes were built above ground, many of them were built into the mountainside. It really depended on the lie of the land around a concession, for example, Ánimas in the Jaroso valley, had steep slopes so was able to have an underground explosive store. The aljibe type structures tended to be right at the top of the mountain.

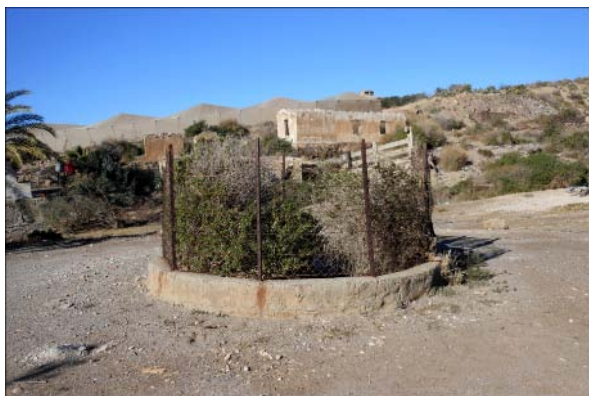
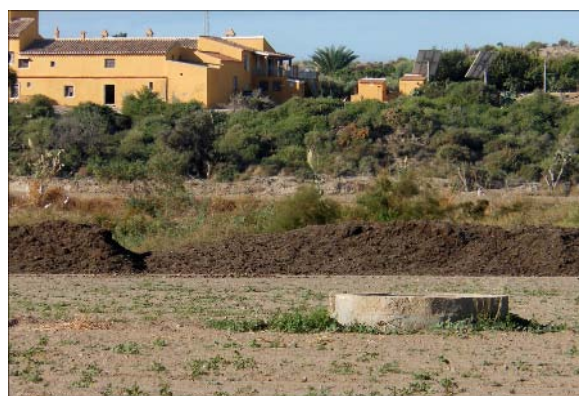
Not all holes in the ground with water at the bottom are wells. What looks like a well, round by the goat pen in El Arteal isn't a well at all (below, left). It is a pocillo, or little shaft, probably sunk as a trial in 1898 when the first drainage tunnel was driven. The water in it drains from mine workings and has percolated through the conglomerate. Although smelling sulphurous, it is not thermal water but neither is it fit for human consumption.

Definitely not a well!

There is a similar one in the field between the miners' quarters and the Rambla de Muleria, (above, right) that also has water in it. What purpose this one served I don't know, but it is unlikely to be potable.

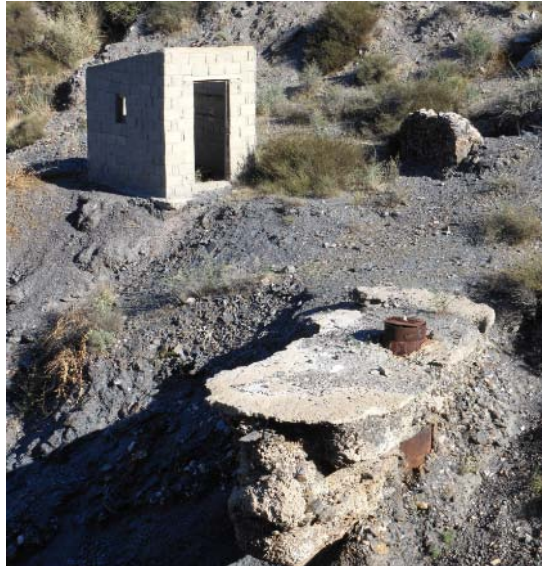
Another strange, water associated feature is to be found in the Barranco de Sima. This is obviously relatively recent, as the pump house is made of breeze block rather than the usual county rock. Someone was prospecting for water for what ever reason, whether looking for a source of irrigation water or thermal water I have no idea. I do wonder if it was associated with Peñarrolla's investigations into the possibility of extracting lithium from the thermal water under the Sierra. However, for the time being, it remains a mystery.

*Built in an attempt to
find water in the
Barranco de Sima.*

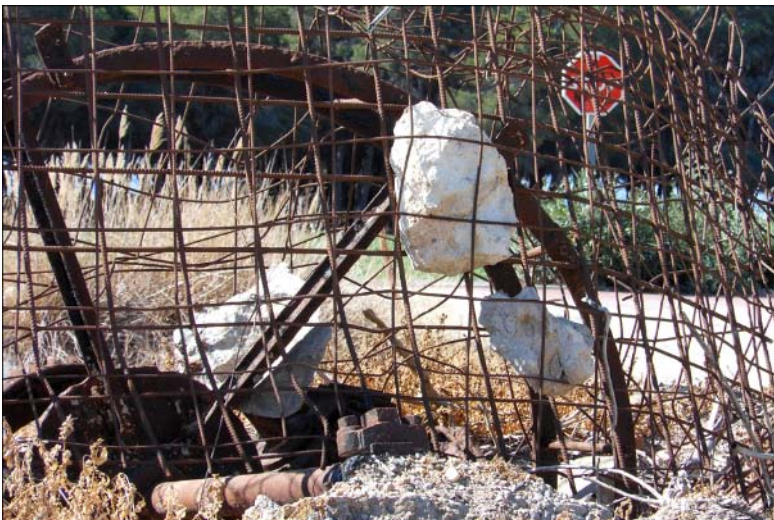
When I read his account, I started to wonder about the rusty looking wheel, covered in wire mesh, surrounded by concrete that is at the edge of a field, opposite the pine grove. Could this be the remains of a noria?

The rusty looking wheel in the field.

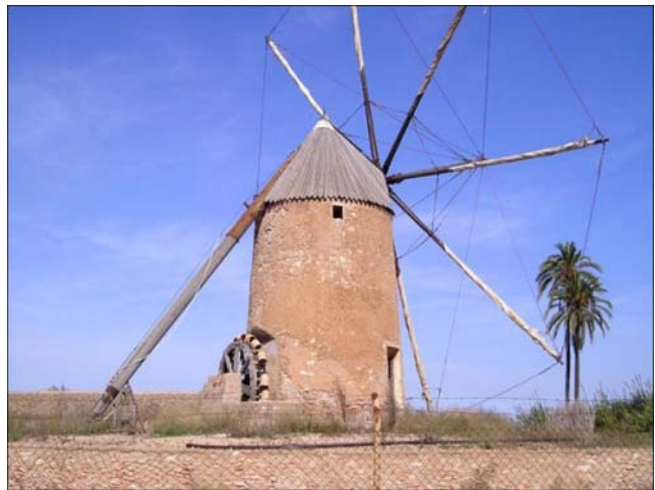
*Remains of a wind powered noria.
Spanish Waterworks. Jill Dickin Schinas.*

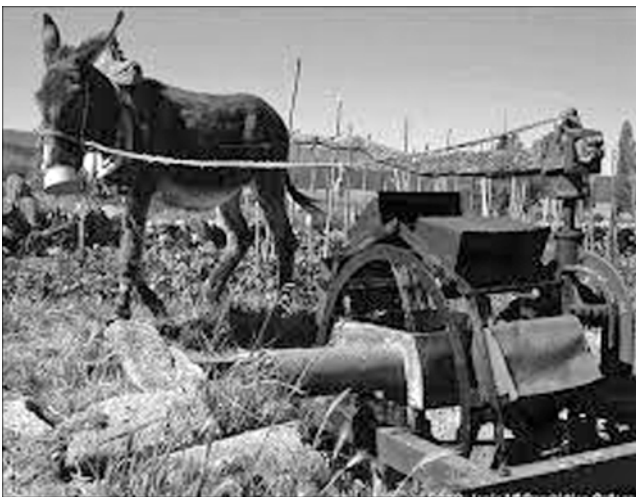
With my curiosity piqued, I started researching norias. I had, indeed discovered the remains of one, not a wind powered one but a “noria de sangre”. The use of the word “sangre” or blood, sounds rather melodramatic, but when applied to a machine, it simply means animal traction. It was a mule powered water lifting machine. Such machines are known as “aceña” in other parts of Spain.

A noria de sangre in use.
