THEN, THERE WERE MINES

Volume
3

Chapter 1. Water, But Not Enough To Drink.

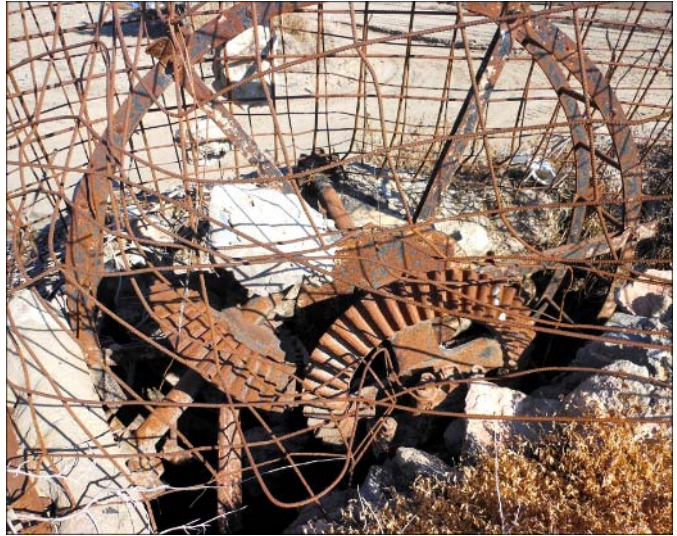
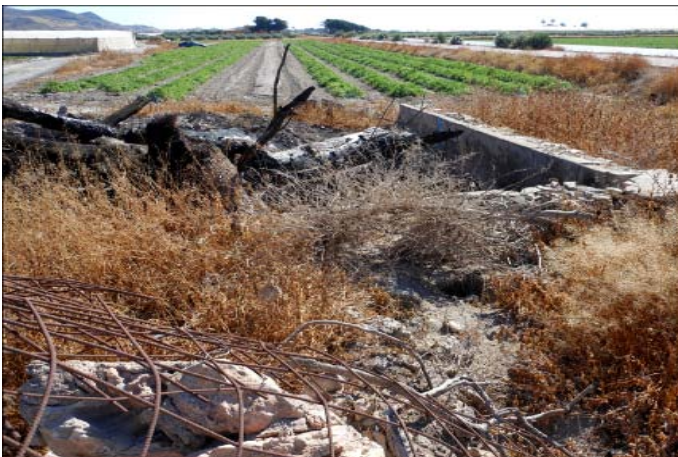
The remains of the transmission gearing and the water wheel of the Madrileña Noria.

The water was channelled into this balsa.

The size of the balsa alongside the noria gives some indication of the efficiency of the machine. I assume that the channel between the waterwheel and the balsa was covered so that the diameter of the mule's circle was not excessively large.

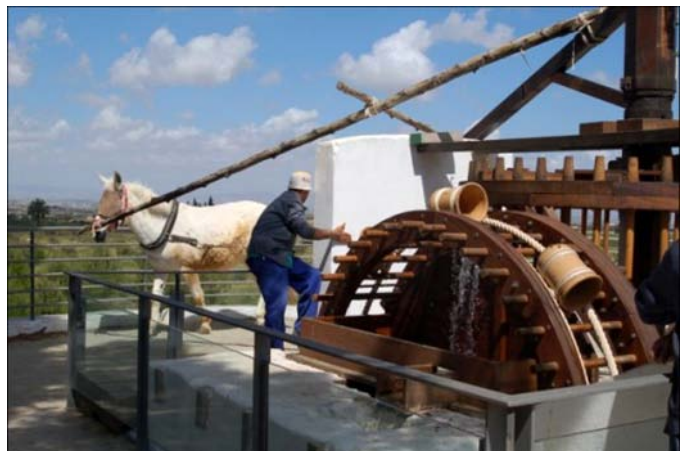
A noria in use. Note that the animal is blindfolded to prevent giddiness.

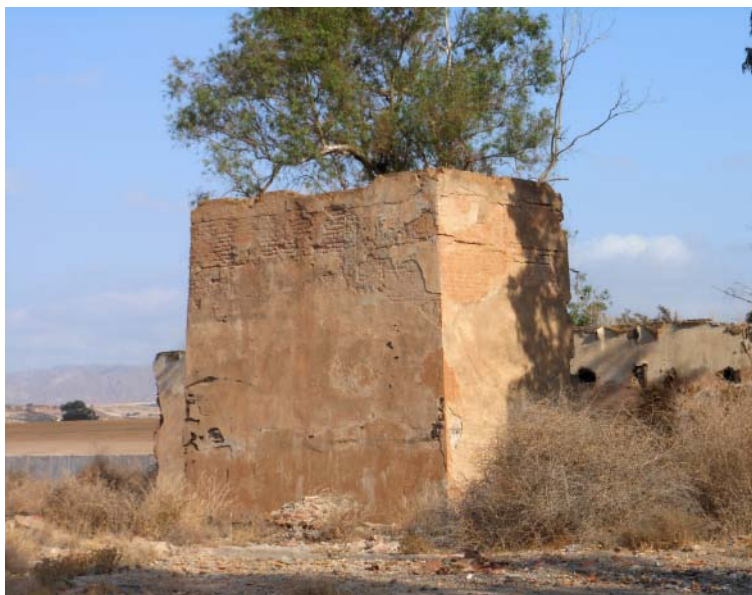
When El Arteal was remodelled in 1908 by the Compañía Minera é Industrial Para España, a rather sophisticated water purification plant was installed. It's purpose was not to provide potable water, but to provide water which was free of lime. The water from the Las Rozas well contained very high levels of calcium carbonate, magnesium, calcium and sodium sulphate, which together with the sodium chloride also present in it, had a serious effect on the boilers. Using the water resulted in corrosive encrustations 12 or more millimetres thick in just two weeks of operation. The encrustations had to be chipped off, an operation which took several days and damaged the internal surfaces of the boilers.

This tower supported a large water tank.

Water was pumped up to a large tank situated above the tower shown. In a separate receptacle, mounted on an iron tripod above the tank, sodium carbonate was dissolved in constantly steam-heated water. Then, in carefully measured proportions, water containing the reagent was piped into large capacity tanks. Steam jets were fed into the tanks so as to speed up the chemical reaction of the sodium carbonate on the water. The treated water was then passed into six circular tanks where the various salts precipitated out. These were extracted and, after passing through a series of filters, the water was ready for use. Due to the combination of the chemical action of the reagent and the physical action of the heat, the water was free of lime salts, but did still contain small amounts of magnesium and sodium salts. Using water treated in this way, the boilers simply needed washing out with jet of water once a fortnight.

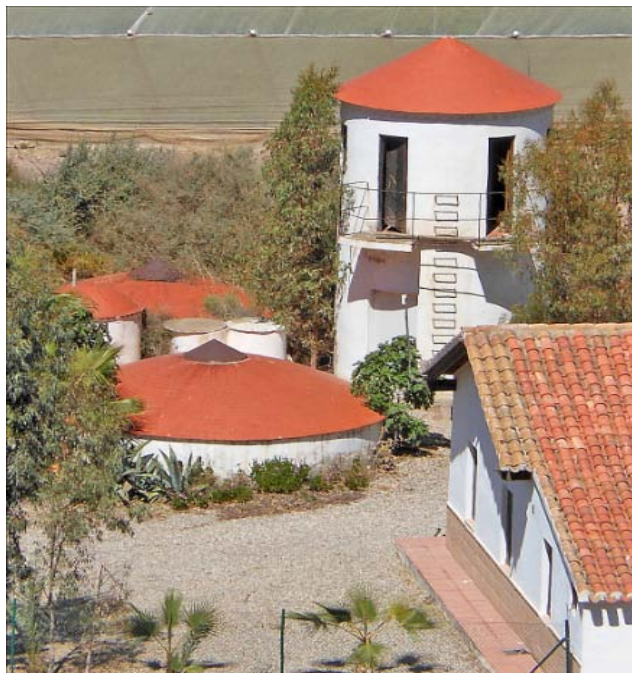
“Rapunzel's Tower”, the water filtration and storage system next to the doctor's old house.

For a long time I thought that this tower, pictured below, was a type of shot-tower, and that the small domed structures next to it were old smelting furnaces. How wrong can you be? It was a water filtration and storage system. Fortunately, it wasn't demolished when the adjacent house was refurbished. In fact, rather a feature was made of it, making it look like something from a fairy story.

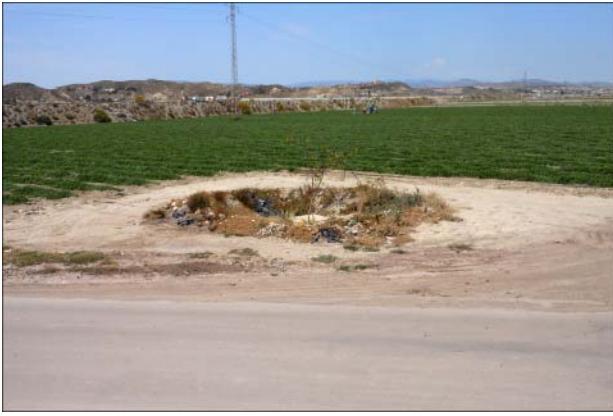
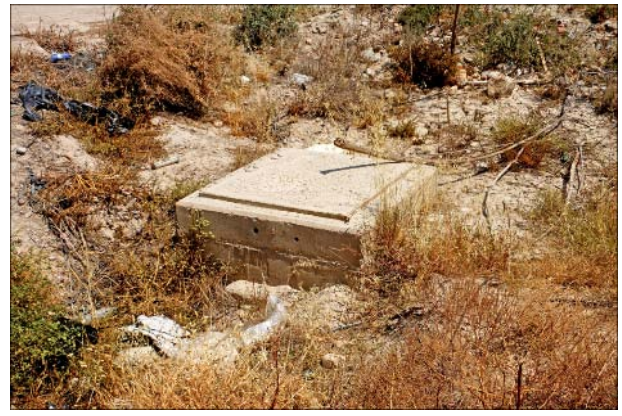
The water was definitely not potable, the warnings about this fact can still be seen by the sinks in some of the miners' quarters. It still came from the same well in Las Rozas, which was sunk in 1898 when the El Arteal pumping station was built. Now capped, it was opposite the junction of the Las Rozas road with the Las Herrerías to Palomares road. I assume that MASA installed a new pump, but I don't know whether or not they renewed the original steel pipeline.

The well, above, has now been capped, right.

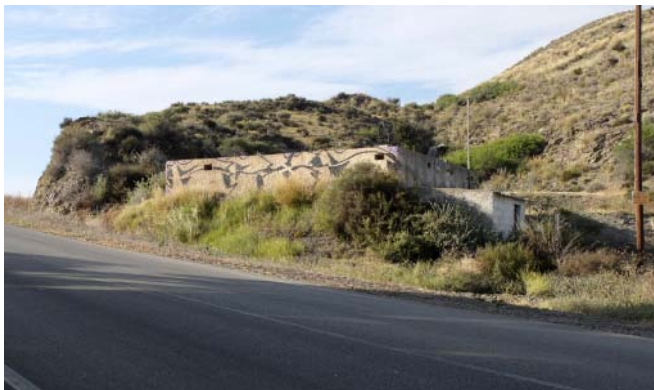
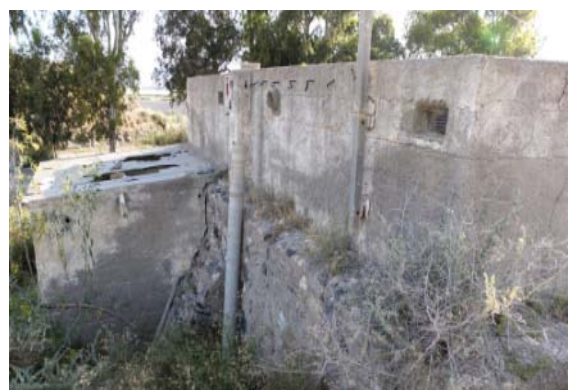
MASA also supplied Villaricos with both potable and non-potable water. The drinking water was brought in by tanker, while surface water was collected, filtered using white netting and stored in metal deposits at Patio Borracho. I think that the ugly, squat building on at the junction of the Palomares river crossing and the Villaricos to Las Herrerías road is the aljibe where the water was collected.

The ugly aljibe by Los Conteros.

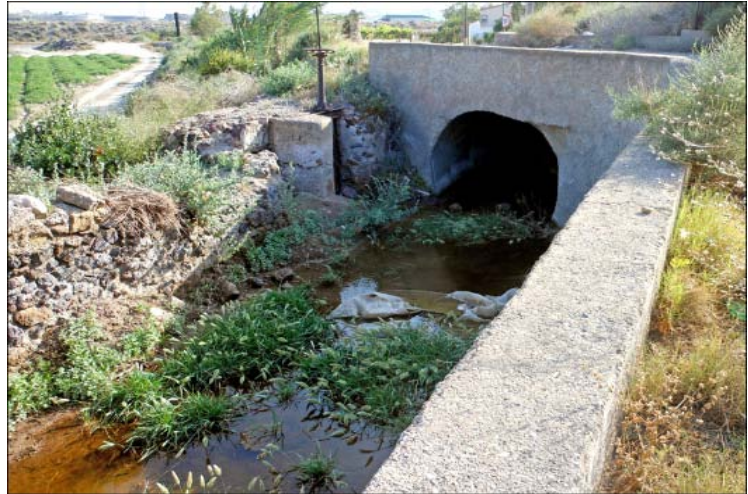
The well preserved acequia in Las Rozas.

The one that runs down through Burjulu, round Las Herrerías and through Las Rozas is one of the best preserved ones in the neighbourhood. The flow of the water could be diverted by means of sluice gates.

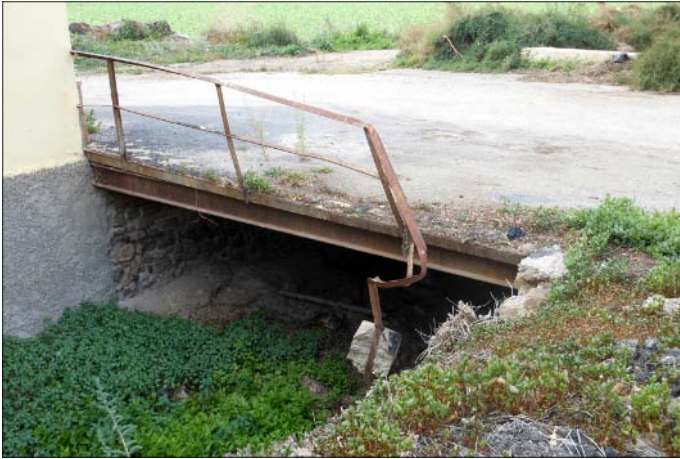
Right, the sluice gate mechanism by the road crossing.

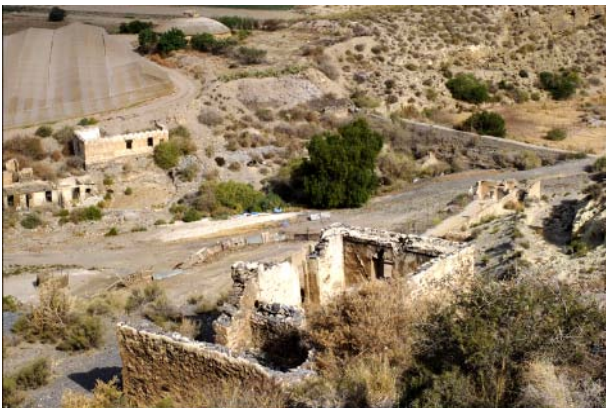
The acequia which runs along the track by the entrance to El arteal was fed from the Rambla del Arteal. To achieve this, the Rambla del Arteal was dammed by the wall just past the goat pen. The remains of the sluice gate and the tunnel which fed the water under the hill are still there. The water then was piped under the track and into the ditch. Any excess was stored in a small deposit that used to be next to the olive grove

The wall damming the Rambla del Arteal can be seen in the centre right of the picture.

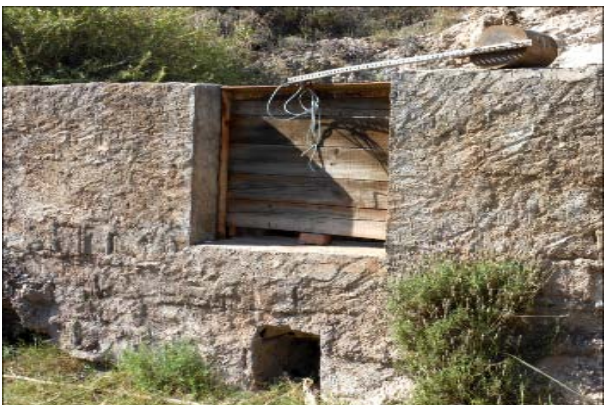
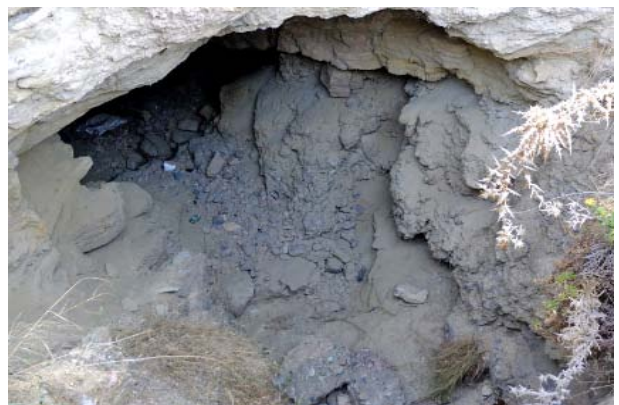
The sluice gate and the entrance to the water channel under the hill.

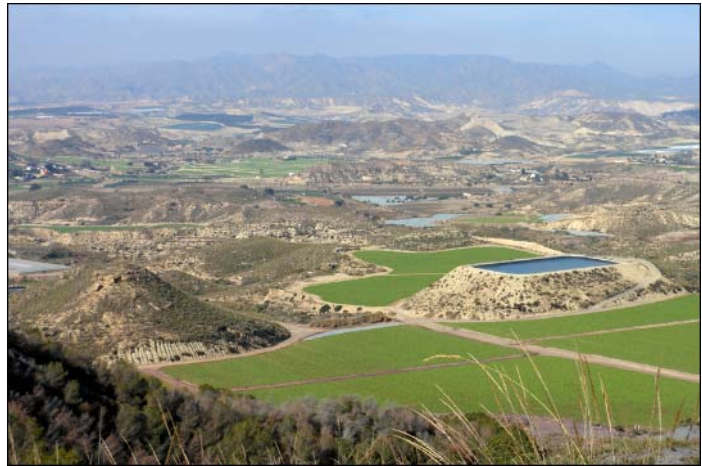
When the Almanzora was canalized, the feed to the many of these irrigation ditches was lost. The fields were then irrigated by means of large water deposits. In addition to collected rainwater, groundwater from wells, such as the one at Las Rozas, was pumped up into these irrigation deposits. There used to be several of these agricultural reservoirs in the area. As they were constructed on high ground there was sufficient pressure to gravity feed crops via irrigation pipes. Nowadays only one or two are maintained.

One of the few agricultural water deposits still in use.

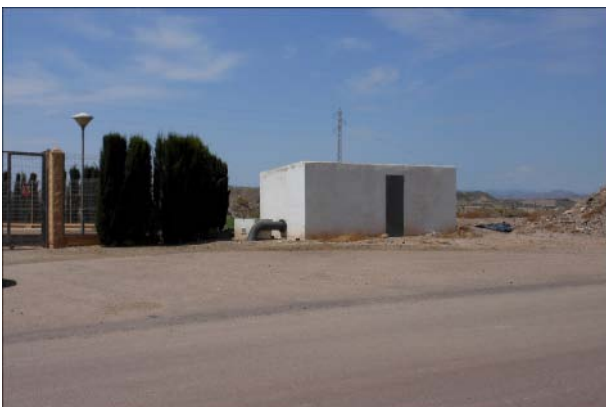
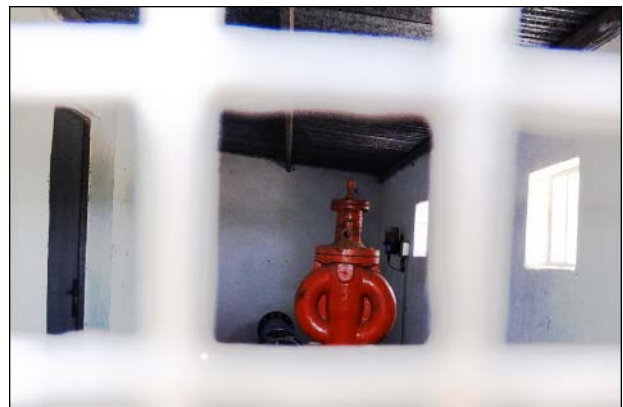
The pump house next to the Portillo substation and inside the building.

The rise of giants like Primaflor, and horticulture on an industrial scale, necessitated better irrigation infrastructure. This innocuous building by the Portillo substation in Las Rozas houses a modern pump. It is one of the main sources of agricultural water for the immediate area. Whether it pumps groundwater or

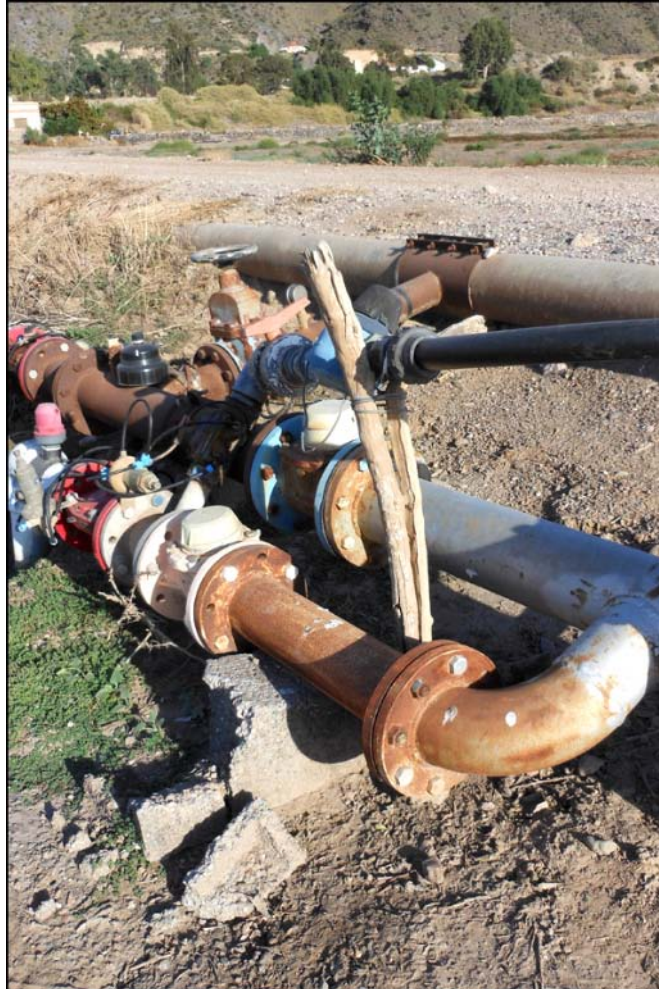
While horticulture is on an industrial scale, and the infrastructure is monitored, the maintenance of it is somewhat 'laissez-faire'. The stick in this picture has been supporting the high pressure pipe for several years now.

The pipe and the stick.

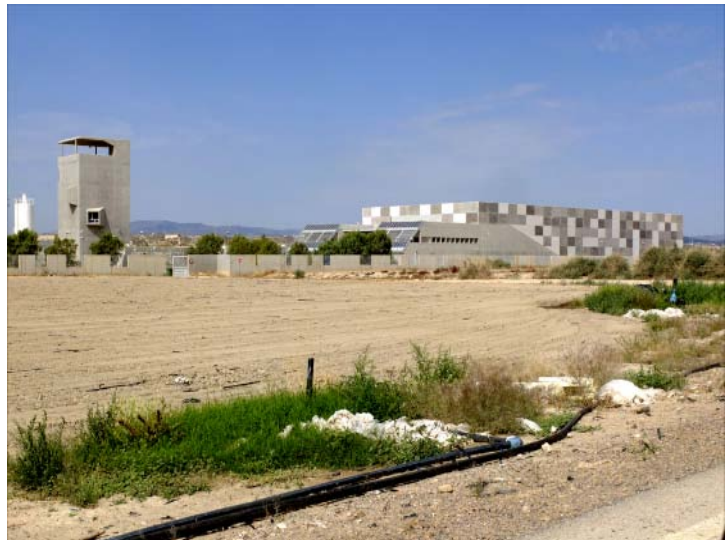
The now derelict desalination plant.

The Bajo Almanzora plant at Villaricos was started in 2009 and opened in 2011. It supplied 20 cubic hectometres of desalinated water. 80% of which was for irrigation, 12% for urban use, 1.20% for leisure, e.g. golf, and a mere 0.80% for industrial use. It wasn't universally welcomed by local growers, as desalinated water cost them more than transferred water.

The floods of 2012 wiped out the €77 million installation.

Hopefully, it was built able to accommodate the contaminants present in the sea water. However, the question has to be raised. Why it was built where it was? Didn't anyone remember that the same place was flooded as recently as 1973?

“Following the effects of the heavy flooding of the “Bajo Almanzora” desalination plant caused in September 2012, the purpose of this project is to perform detailed design services to improve the flood protection of this facility. Many different studies were carried out and finally the solutions chosen were: enlargement of Canalejas watercourse capacity by modifying the cross section avoiding flooding, improvement of the access road slope by using geo-textile and by rip-rap along the road slope, an overpass over “Canalejas” watercourse (4 spans precast bridge, 33m each), heightening the border of the plot of the

desalination plant, 13 drainage works (diameter 1000-1200 mm and flow 2.17-8.37 m³/s) in order to lead the storm water to Almanzora river or Canalejas watercourse, a pump station with 5 submersible pumps (2.100 l/s each) and a drainage trench.”

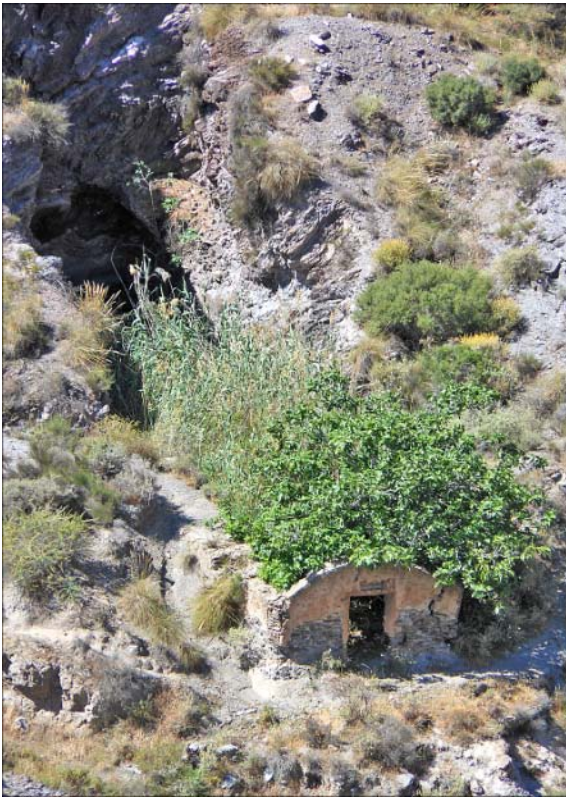
The aljibe in May 2015 ...

The fragility of the environment was brought home to me when I walked up the Barranco de Las Palomas in January 2016. The pictures below show the dramatic change that occurred in just nine months.

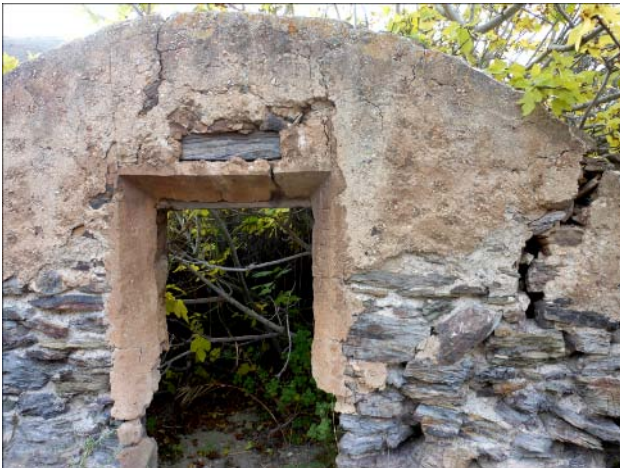
The front of the aljibe in May 2015 ...

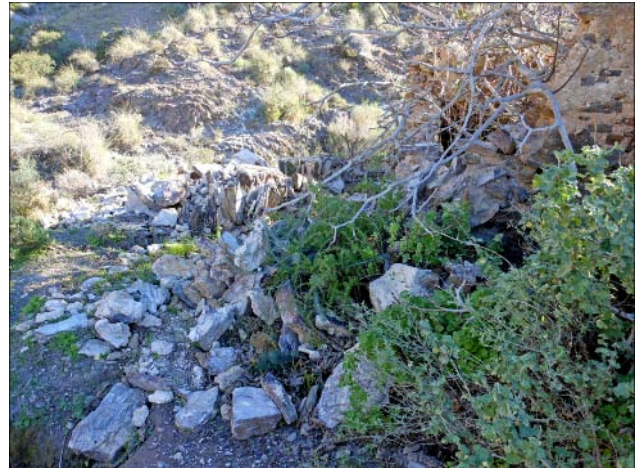
and all that remained by January 2016.

That January day, climbing out of the bed of the rambla and approaching the aljibe, a sorry sight met my eyes. The entire front had collapsed, the stones littered the path. Some traumatic event had occurred.

Scrambling up to the side of the aljibe, the reason for the collapse became apparent. It had been flooded, and the force of the water had demolished the front wall. The overflow, which would have been at the front, had long since been blocked, so there had been no escape for the excess water. But why now? Why had so much water entered the aljibe? On previous visits only rainwater had collected there and I didn't know where any other water was collected from.

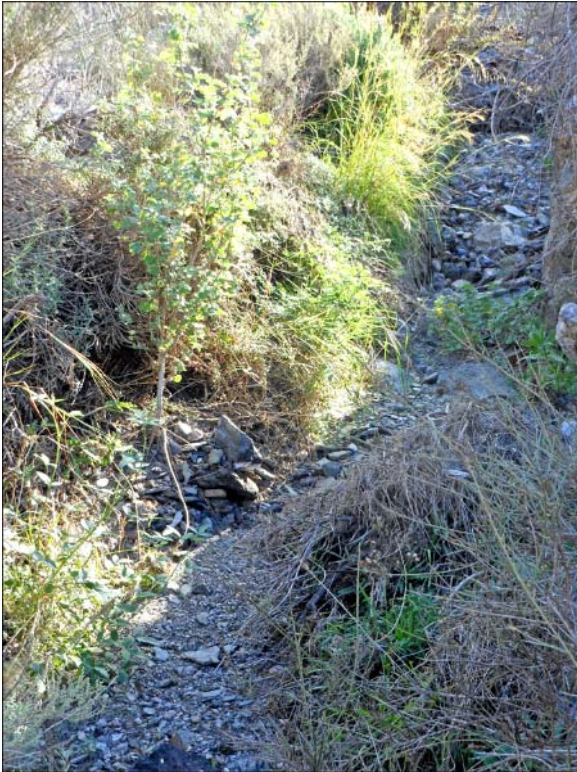
Above, the revealed sedimentation tank.

The answer was clear, the rush of water had revealed the sedimentation tank and the entrance channel. It was channelled in from the side, diverting the water away from its path to the Rambla de Las Palomas.

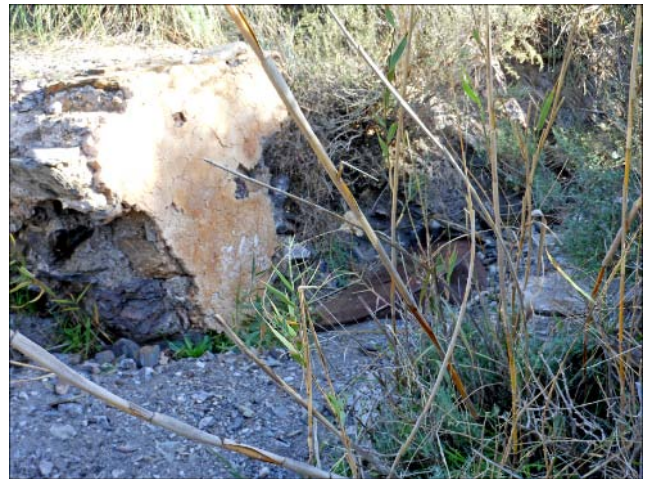
Left, the revealed water channel at the side of the aljibe.

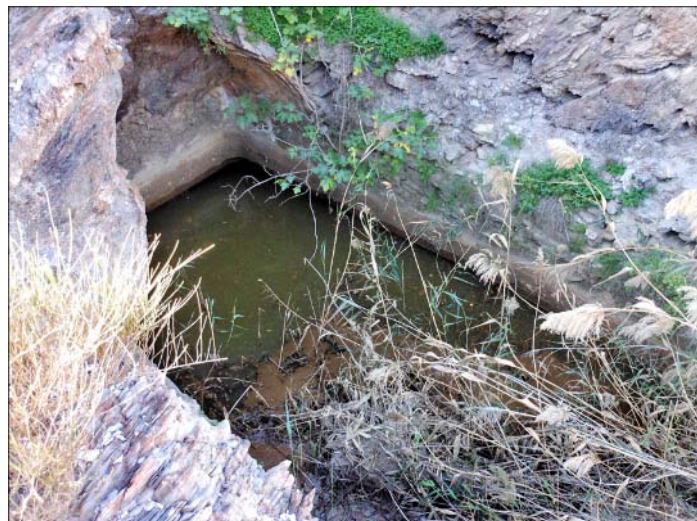
The cistern was quite full of water.

Why had the water suddenly re-found its path into the aljibe after all these years? I found the answer. The bucket, which had “jumped” from the aero cable years ago, had blocked the feed channel and the water had cut a new channel down into the valley. Unearthing the bucket, while causing some excitement to other geeks like myself, had upset the status quo. Such a simple act has had such a far reaching consequence.

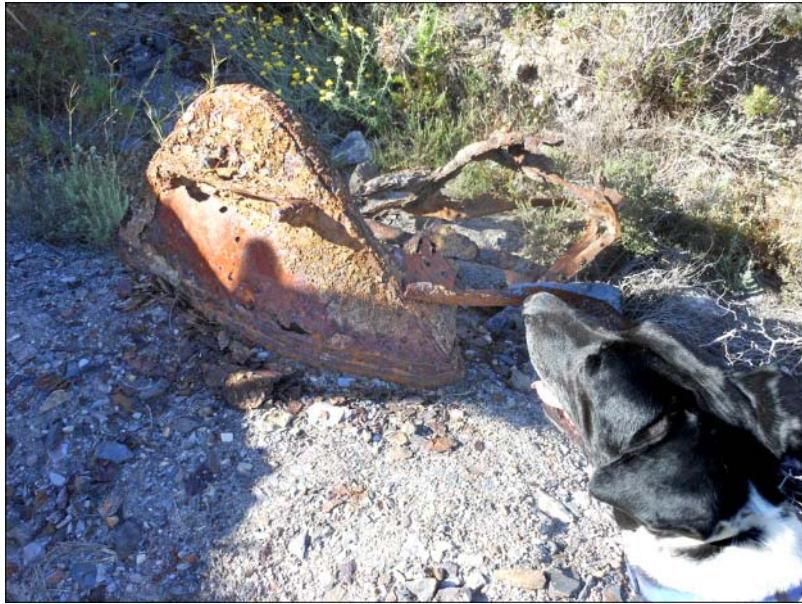
The aero cable bucket and an interested dog.
